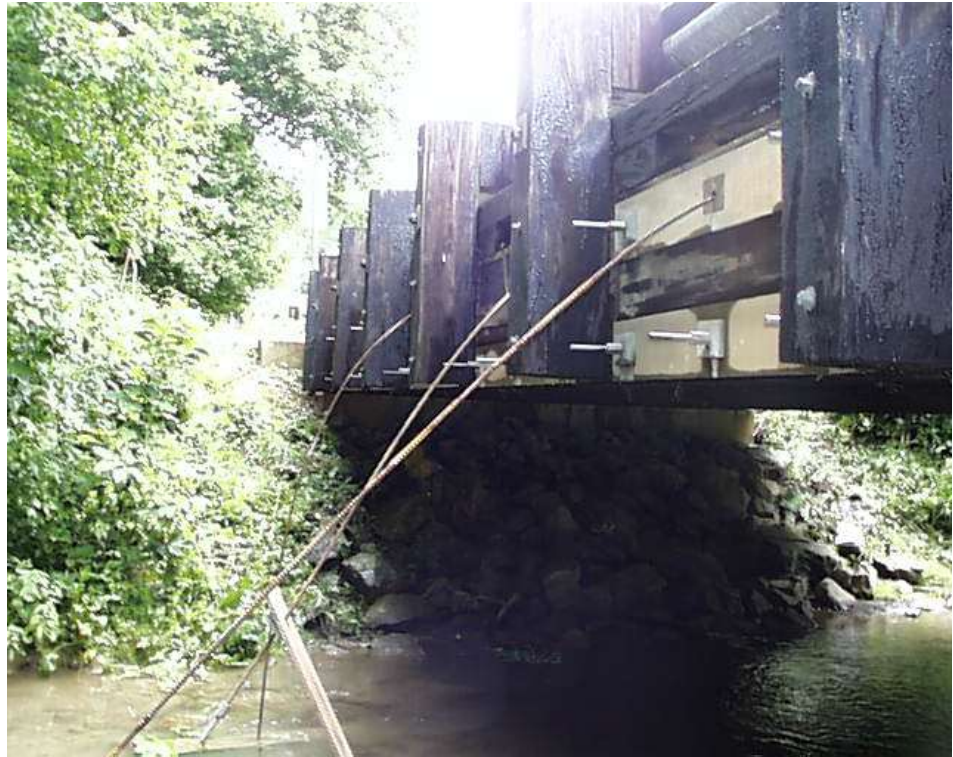
**Figure 8.3.10** Broken Stressing Rods

Examine the condition of the steel stressing rods, and inspect for crush and splits in the fascia members. Check for loss of prestress in the rods, which would be indicated by shifted planks in the stress-laminated timber element and excessive deflection or loose rods. This may be observed when the bridge is subject to a moving live load.

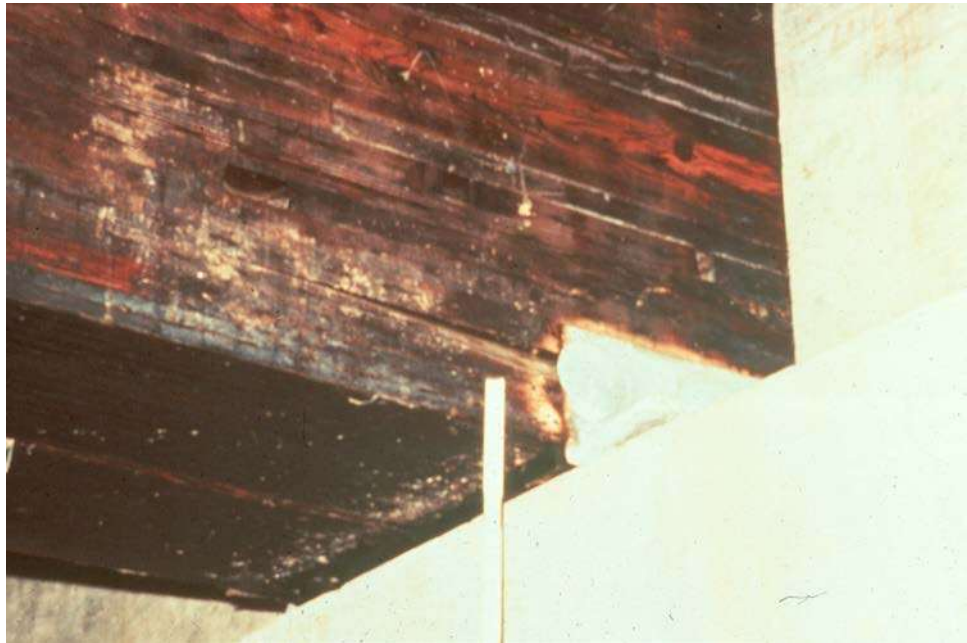
**Figure 8.3.11** Close-up View of End of a Stress-Laminated Timber Bridge Showing Laminations

Examine for horizontal shear cracks and delaminations near the ends of the beam. Delaminations (i.e., separations in the laminations) can occur due to either failure of the glue or failure at the bond between the glue and the lamination (see Figure 8.3.11). Delaminations that extend completely through the cross section of the member are the most severe since this makes the member act as two smaller members.

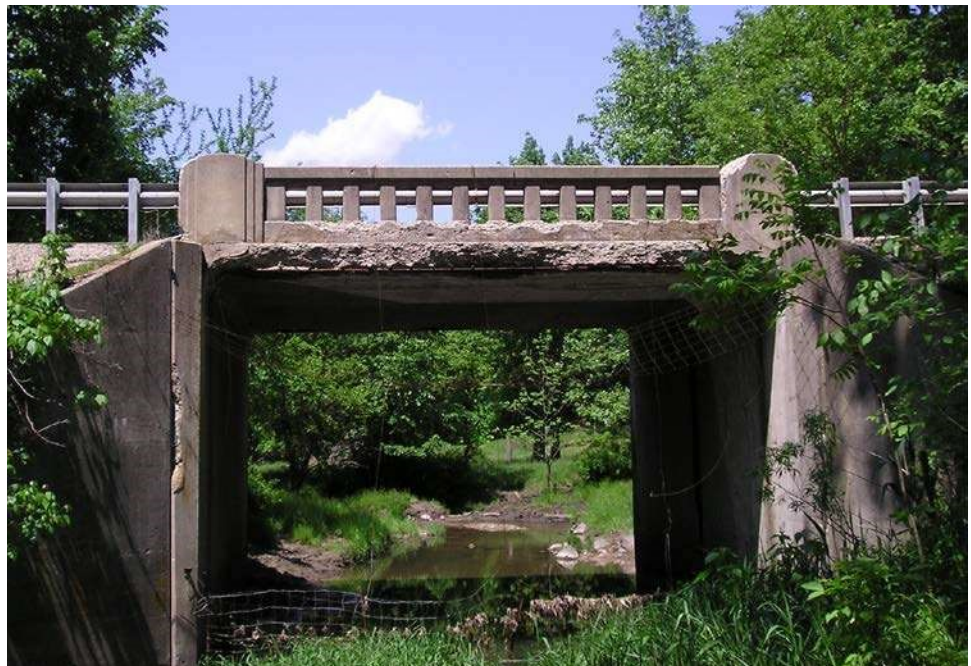
**Figure 9.1.1** Typical Simple Span Cast-in-Place Slab Bridge

The cast-in-place slab bridge is the simplest type of reinforced concrete bridge and was a common choice for construction in the early 1900's (see Figures 9.1.1 and 9.1.2). Sometimes the terms "deck" and "slab" are used interchangeably to describe the same bridge component. However, this is incorrect. A deck is supported by a superstructure unit (beams, girders, etc.), whereas a slab is a superstructure unit supported by a substructure unit (abutments, piers, bents, etc.). A deck can be loosely defined as the top surface of the bridge, which carries the traffic and distributes loads to the superstructure. A slab serves as the superstructure and the top surface that carries the traffic. Even though slabs are defined differently than decks, many of the design characteristics, wearing surfaces, protective systems, inspection methods and locations and, evaluation, are similar. See Topic 7.2 for further details.

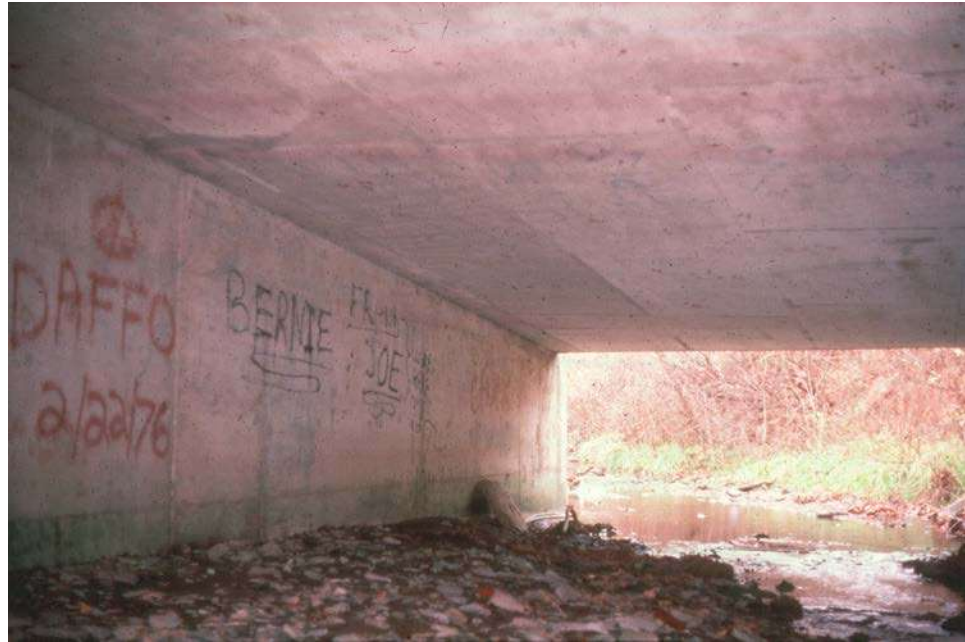
**Figure 9.1.4** Bearing Area: Cast-in-Place Slab

Examine bearing areas for cracking, delamination, and spalling where friction from thermal movement and high edge or bearing pressure could overstress the concrete (see Figure 9.1.4). Check the condition and operation of any bearing devices.

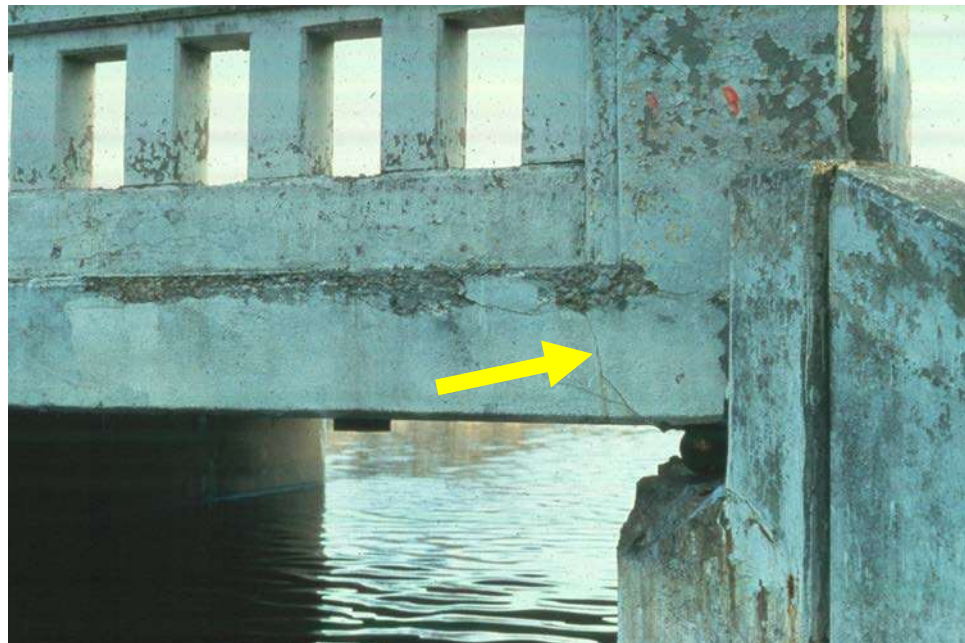
**Figure 9.1.5** Diagonal Shear Cracks Close to the Ends of a Slab Bridge

Investigate areas near the supports for shear cracking. The presence of transverse cracks on the underside near supports or diagonal cracks on the sides of the slab indicate the onset of an overstress for shear (see Figures 9.1.5 and 9.1.6). Carefully measure cracks as they may represent lost shear capacity.

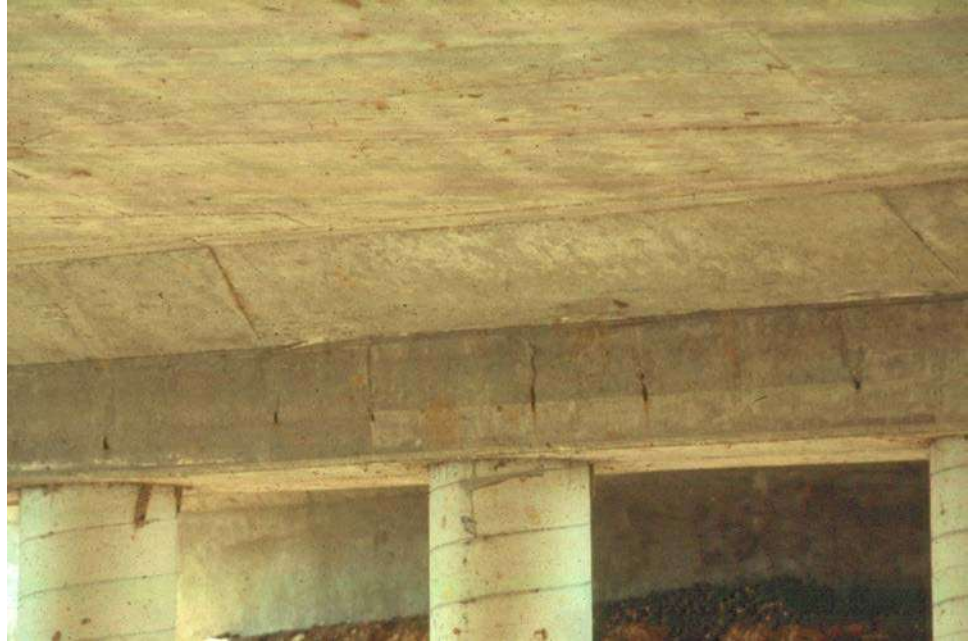
**Figure 9.1.6** Shear Zone on the Underside of a Continuous Slab Bridge Near a Pier

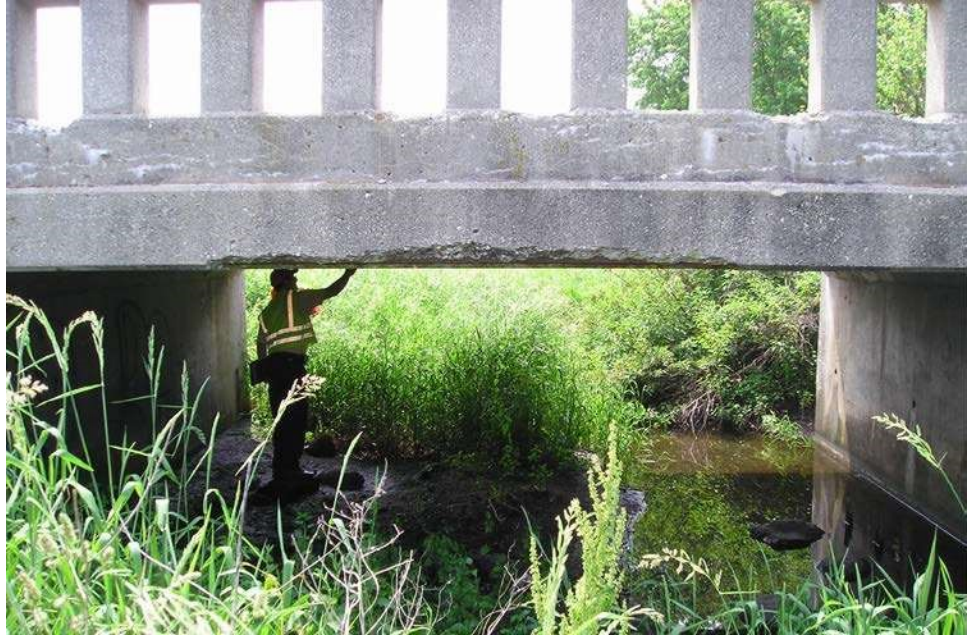
**Figure 9.1.7** Inspector examining and documenting deficiencies in concrete slab

Examine tension zones for flexure cracks, which would be perpendicular to the tensile forces and vertical on the sides and transverse across the slab. The tension zones are at midspan along the bottom of the slab for both simple and continuous span bridges. Additional tension zones are located on top of the slab over the piers for continuous spans. Cracks greater than 1/16 inch wide indicate overstress due to tensile forces caused by bending stresses. Check for efflorescence from cracks and, more significant, the discoloration of the concrete caused by rust stains from the reinforcing steel. In severe cases, the reinforcing steel may become exposed due to spalling. Document the remaining cross section of reinforcing steel since section loss will decrease live load capacity (see Figure 9.1.7).

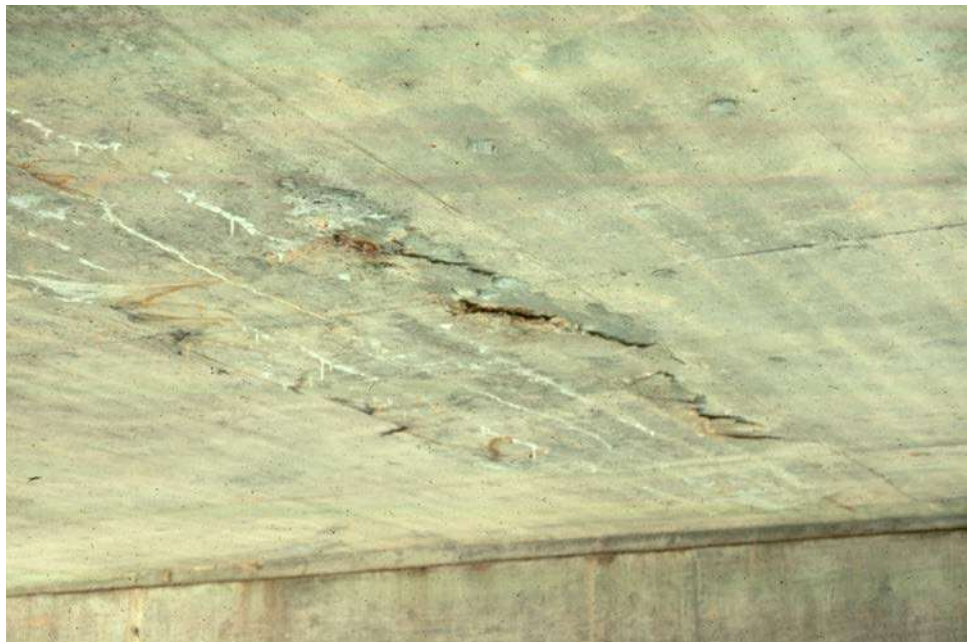
**Figure 9.1.8** Concrete Slab Tension Zone: Delamination, Efflorescence, Rust, and Stains

Check for deteriorated concrete near the tension zones, which could result in the debonding of the tension reinforcement. This would include delamination, spalls, and contaminated concrete (see Figure 9.1.8). Slab bridges which use hooks to develop the primary tension reinforcement are not as susceptible to debonding due to deterioration of the concrete.

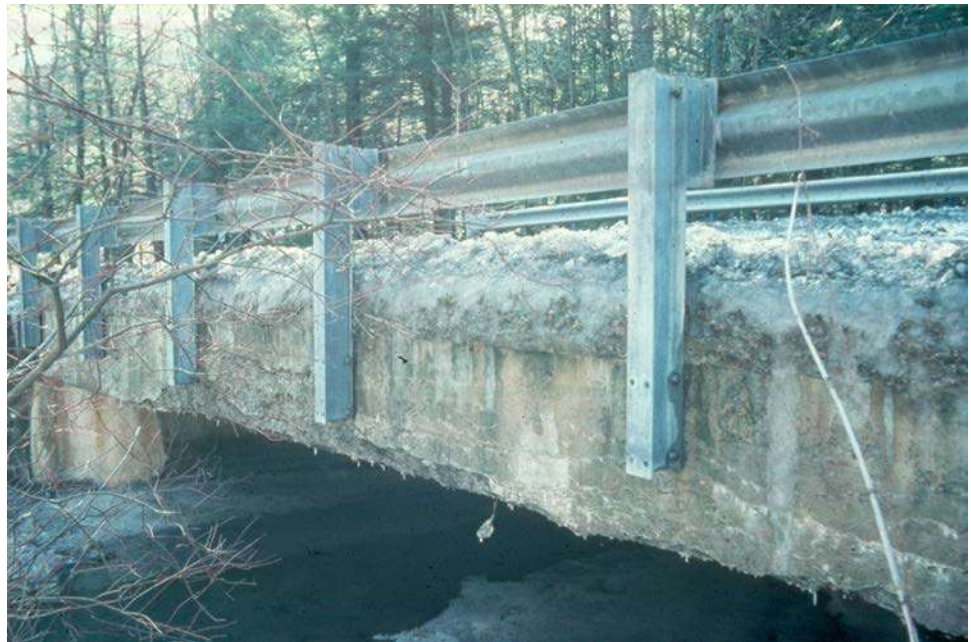
**Figure 9.1.9** Deteriorated Slab Fascia due to Roadway Deicing Agents

Inspect areas exposed to roadway drainage for deteriorated concrete. This includes the entire riding surface of the slab, particularly around scuppers or drains. Spalling or scaling may also be found along the curblines and fascias (see Figure 9.1.9).

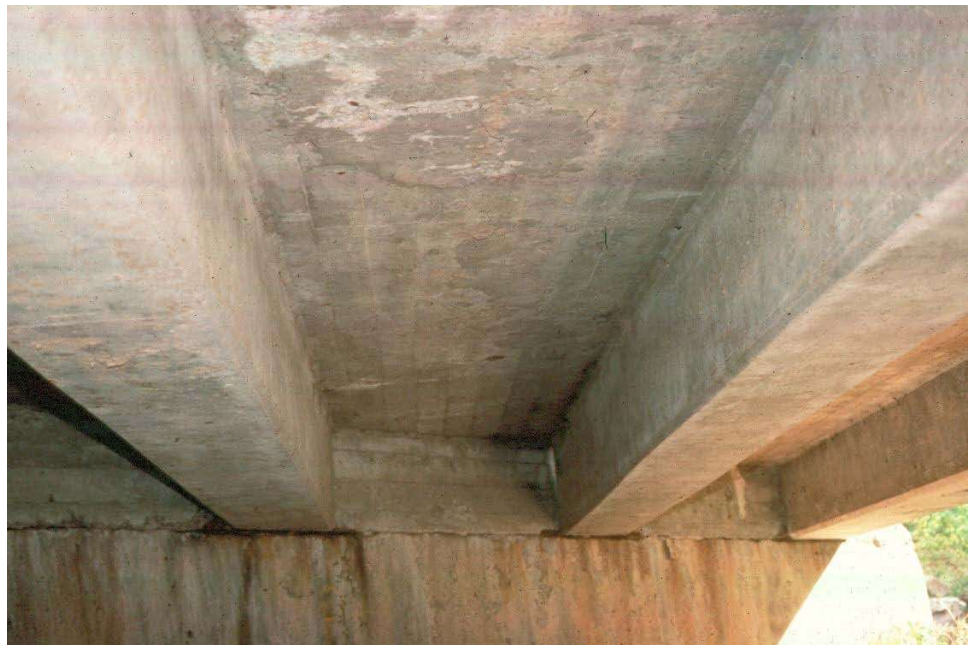
**Figure 9.2.3** Typical Tee Beam Layout

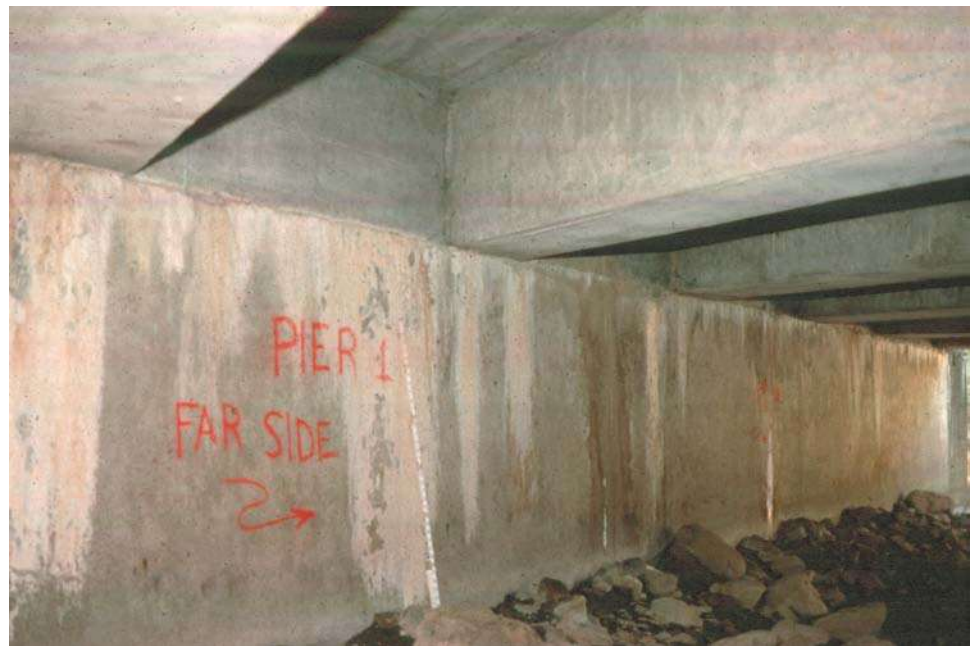
**Figure 9.2.8** Bearing Area of Typical Cast-in-Place Concrete Tee Beam Bridge

Examine bearing areas for cracking, delamination and spalling where friction from thermal movement and high bearing pressure could overstress the concrete. Check for crushing of the stem near the bearing seat. Check the condition and operation of any bearing devices (see Figures 9.2.8 through 9.2.11).

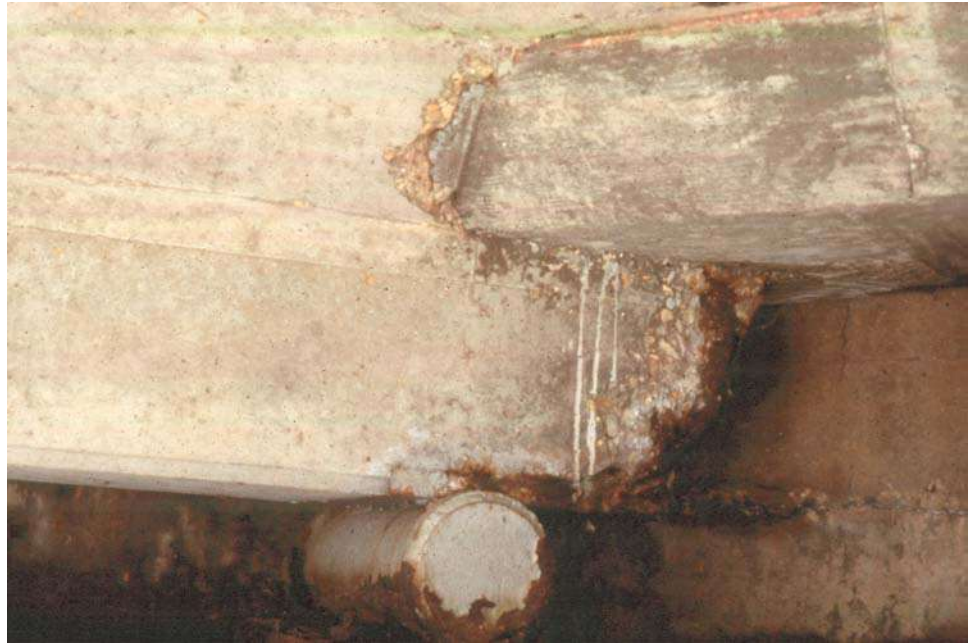
**Figure 9.2.9** Spalled Tee Beam End

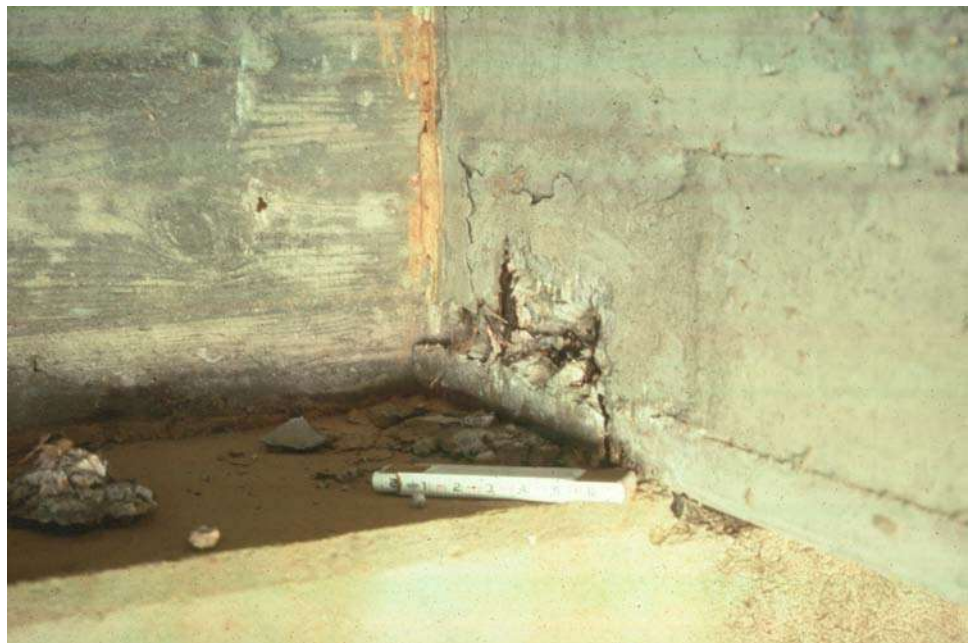
**Figure 9.2.10** Deteriorated Tee Beam Bearing Area

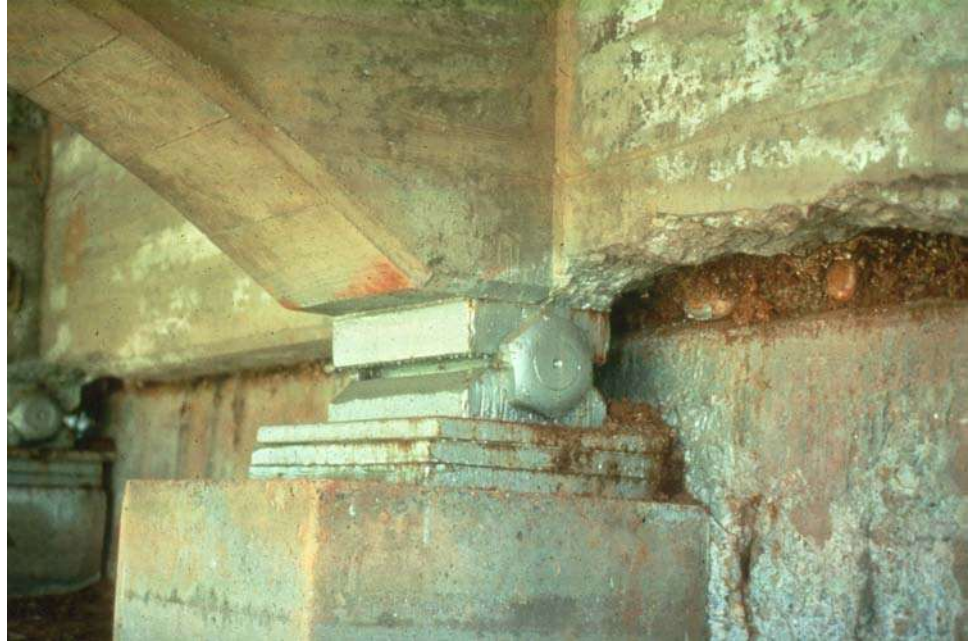
**Figure 9.2.11** Steel Bearing Supporting a Cast-in-Place Concrete Tee Beam

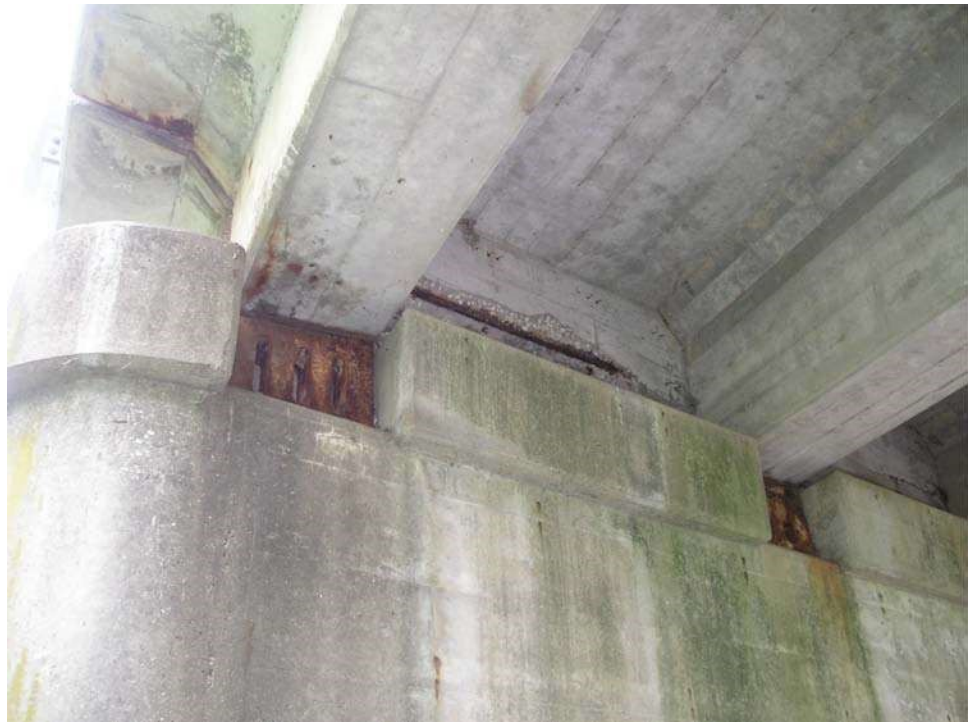
**Figure 9.2.12** Shear Zone of Cast-in-Place Concrete Tee Beam Bridge

Investigate the area near the supports for the presence of shear cracking. The presence of transverse cracks on the underside of the stems or diagonal cracks on the sides of the stem indicate the onset of shear failure. Carefully measure cracks, as they may represent lost shear capacity (see Figure 9.2.12).

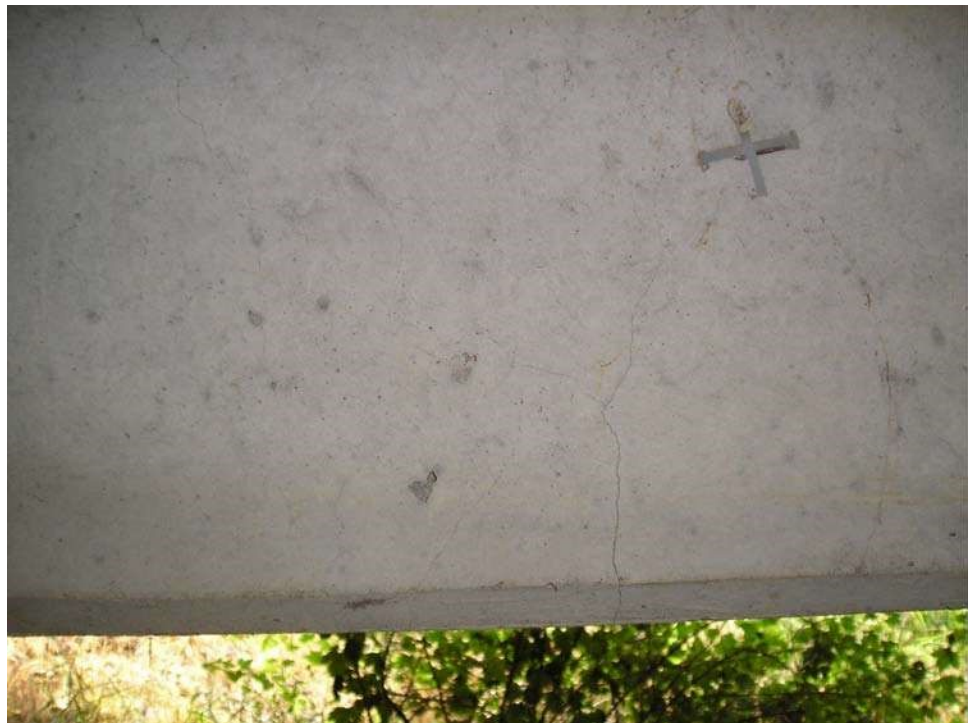
**Figure 9.2.13** Flexure Cracks on a Tee Beam Stem

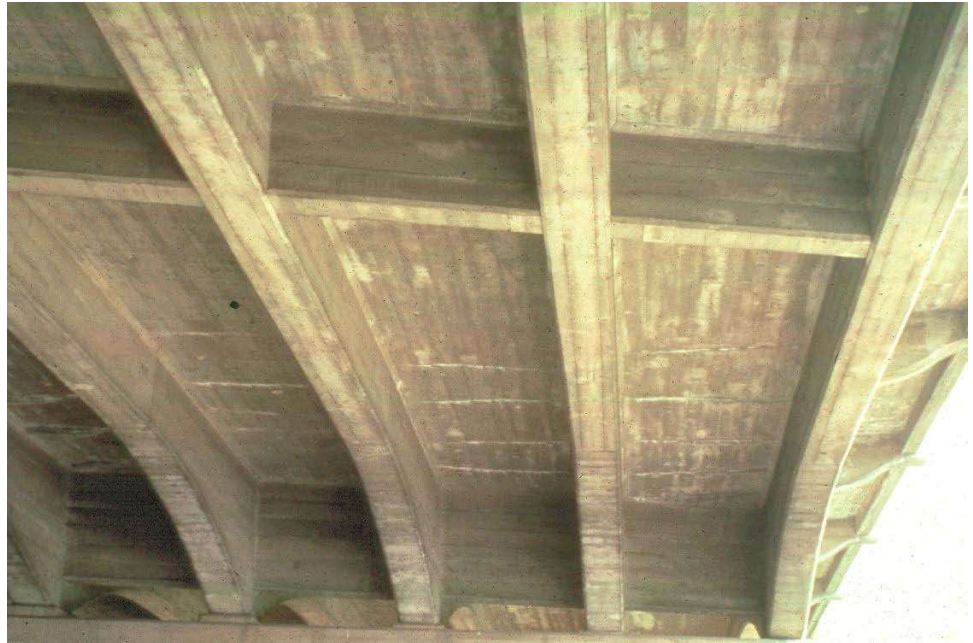
**Figure 9.2.14** Flexure Cracks in Tee Beam Flange/Deck

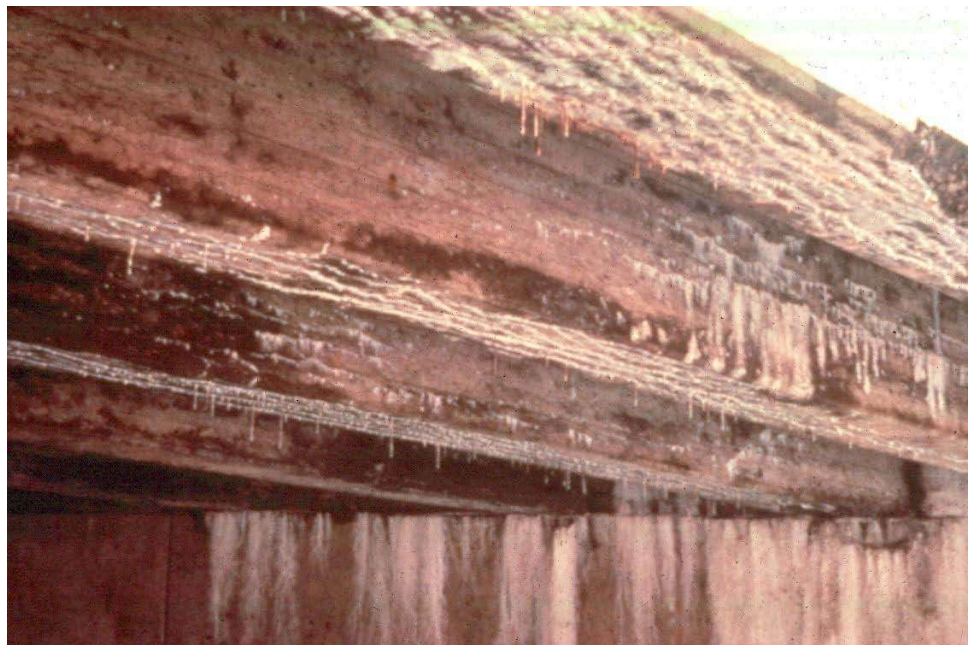
**Figure 9.2.15** Stem of a Cast-in-Place Concrete Tee Beam with Cracking and Efflorescence

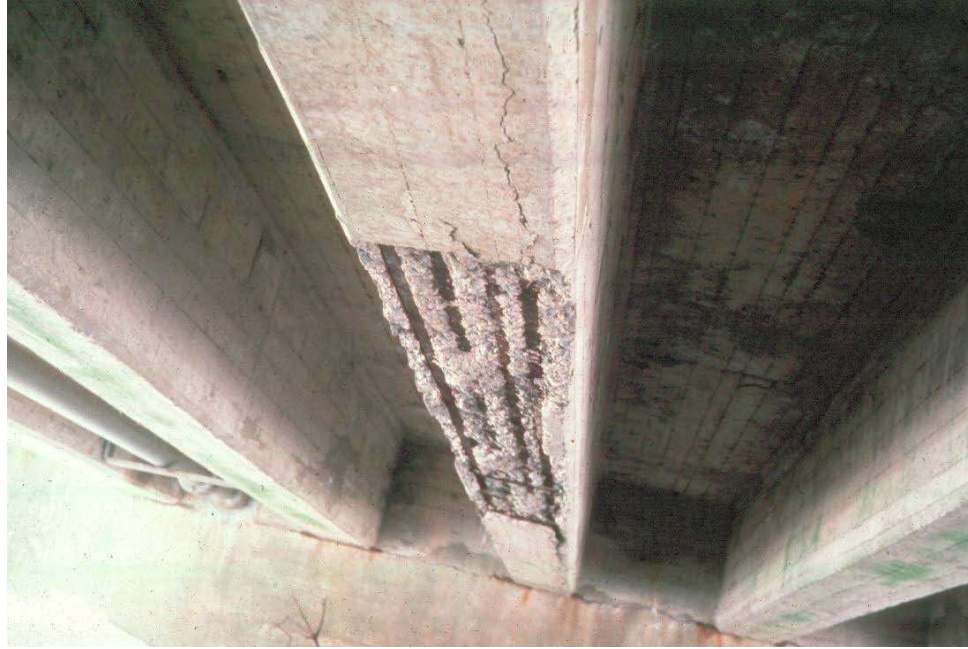
**Figure 9.2.16** Spall on the Bottom of the Stem of a Tee Beam with Corroded Main Steel Exposed

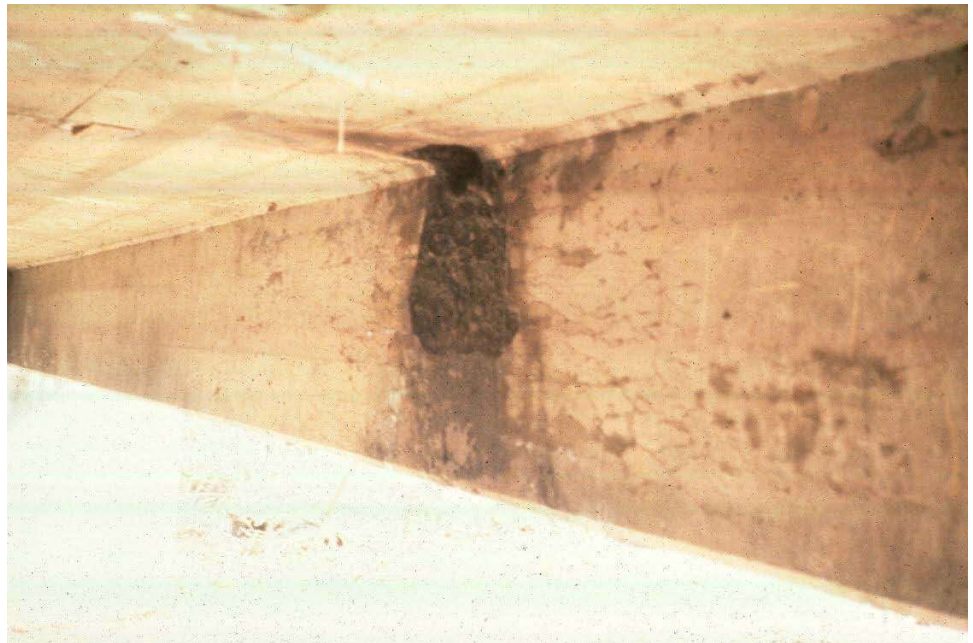
**Figure 9.2.18** Deteriorated Tee Beam Stem Adjacent to Drain Hole

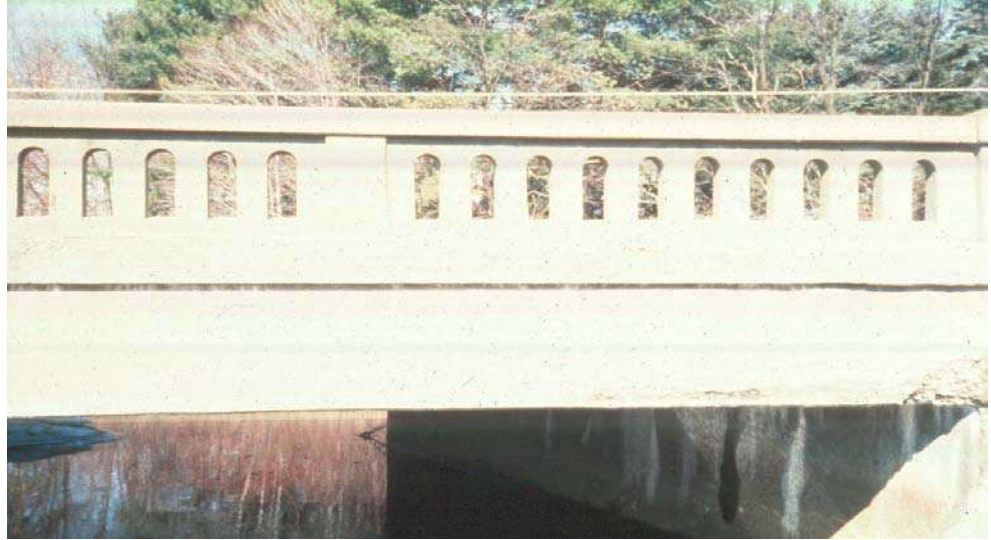
**Figure 9.2.19** Deteriorated Tee Beam End Due to Drainage

Check areas exposed to drainage for concrete spalling or cracking. This may occur at the ends of the stems where drainage has seeped through the deck joints (see Figure 9.2.19).

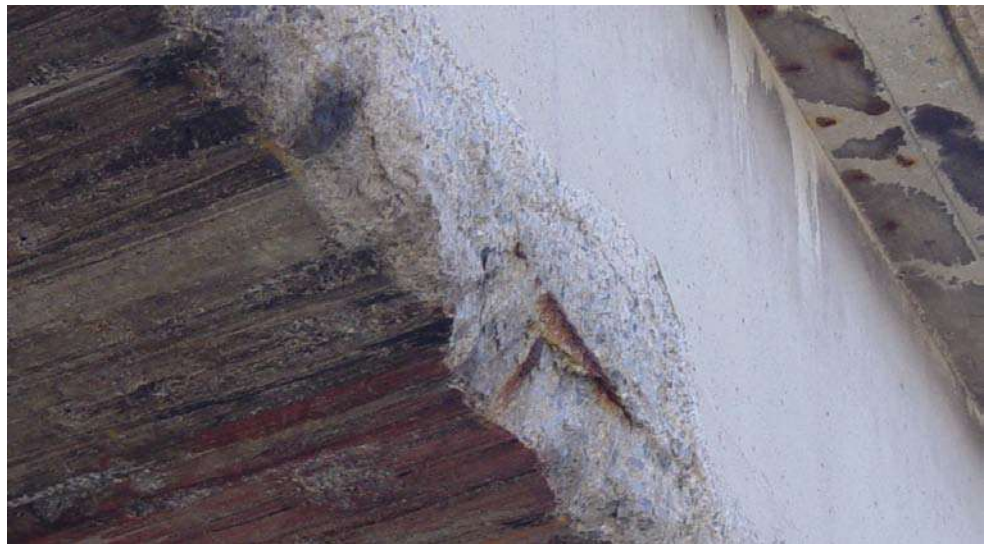
**Figure 9.2.20** Collision Damage to Tee Beam Bridge Over a Highway

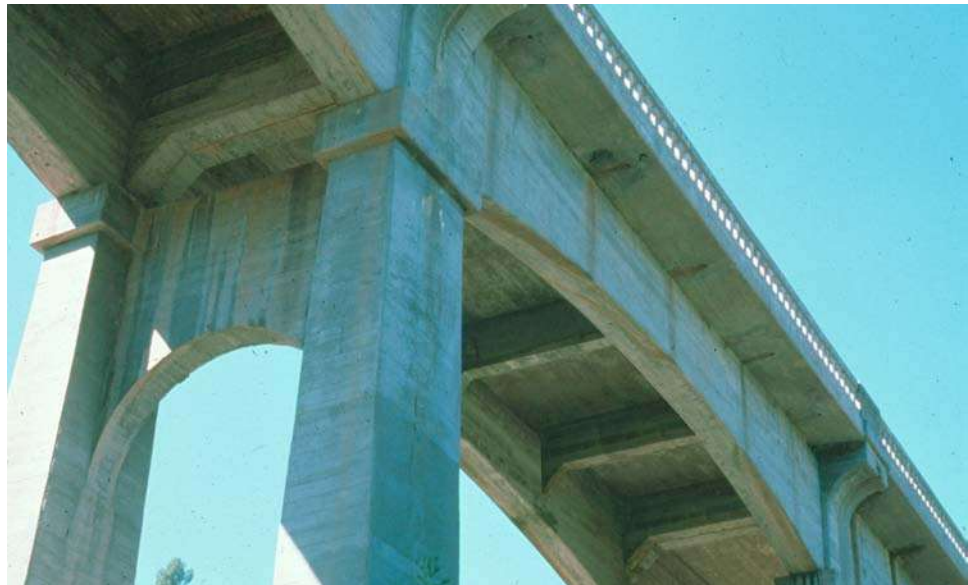
**Figure 9.3.3** Concrete Deck Two-Girder, Underside View

For the purpose of inspection, the deck does not contribute to the strength of the girders and serves only to distribute traffic loads to the girders. As such, the superstructure condition rating is not affected by the condition of the deck. If floorbeams or stringers are present, they are considered part of the superstructure (see Figure 9.3.3).

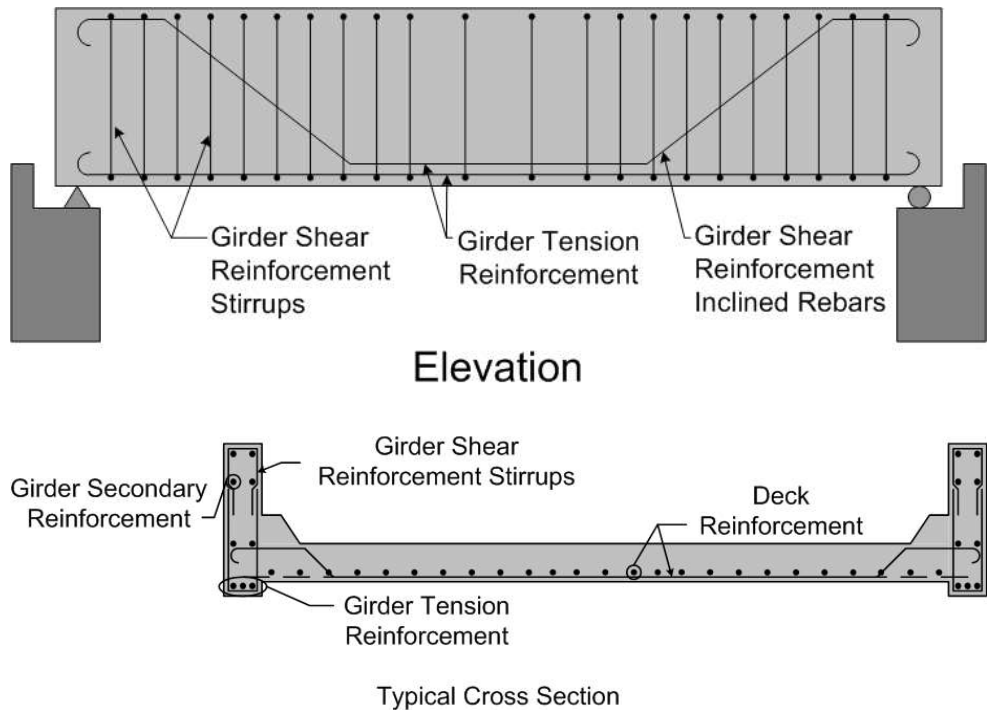
**Figure 9.3.5** Steel Reinforcement in a Concrete Through Two-Girder

The secondary (temperature and shrinkage) reinforcing steel is oriented longitudinally in the sides of the girders (see Figure 9.3.5). The primary and secondary reinforcing steel for the deck portion of the beam is the same as for a standard concrete deck.

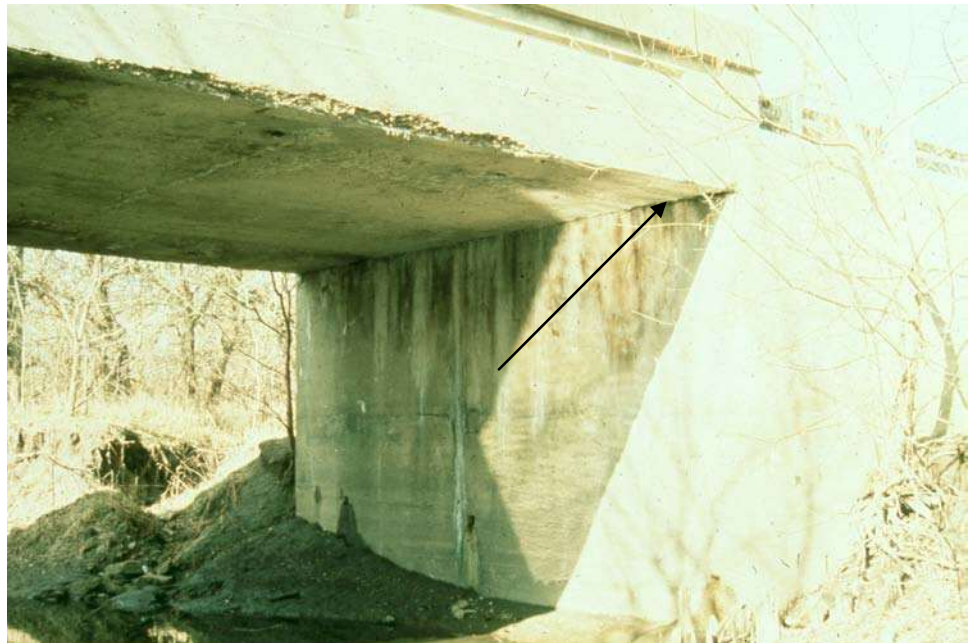
**Figure 9.3.6** Bearing Area of a Through Two-Girder Bridge

Examine bearing areas for cracking, delamination or spalling where friction from thermal movement and high bearing pressure could overstress the concrete. Check for crushing of the girder near the bearing seat. Check the condition and operation of any bearing devices (see Figure 9.3.6).

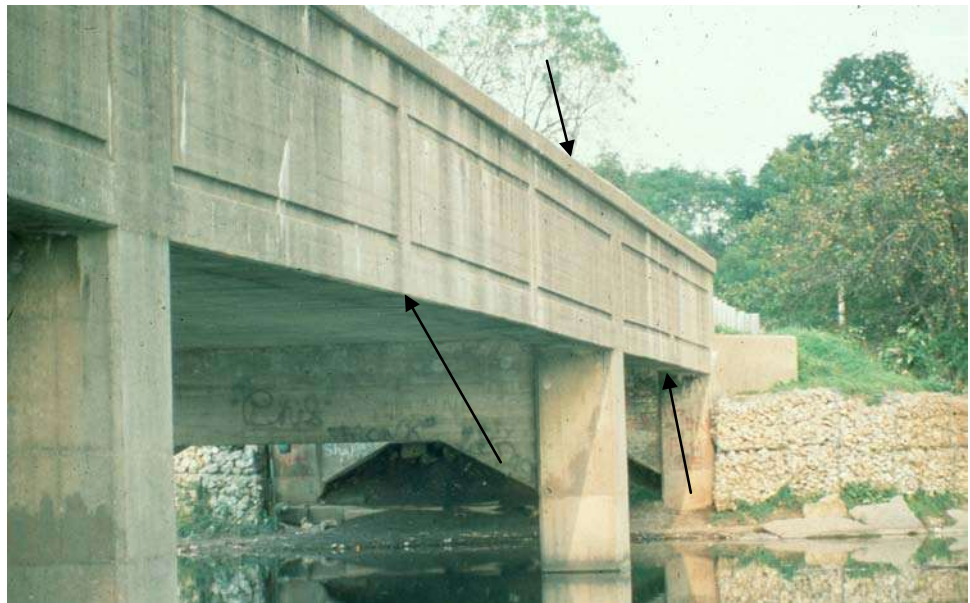
**Figure 9.3.7** Typical Elevation View of a Through Two-Girder Bridge with Tension Zones Indicated

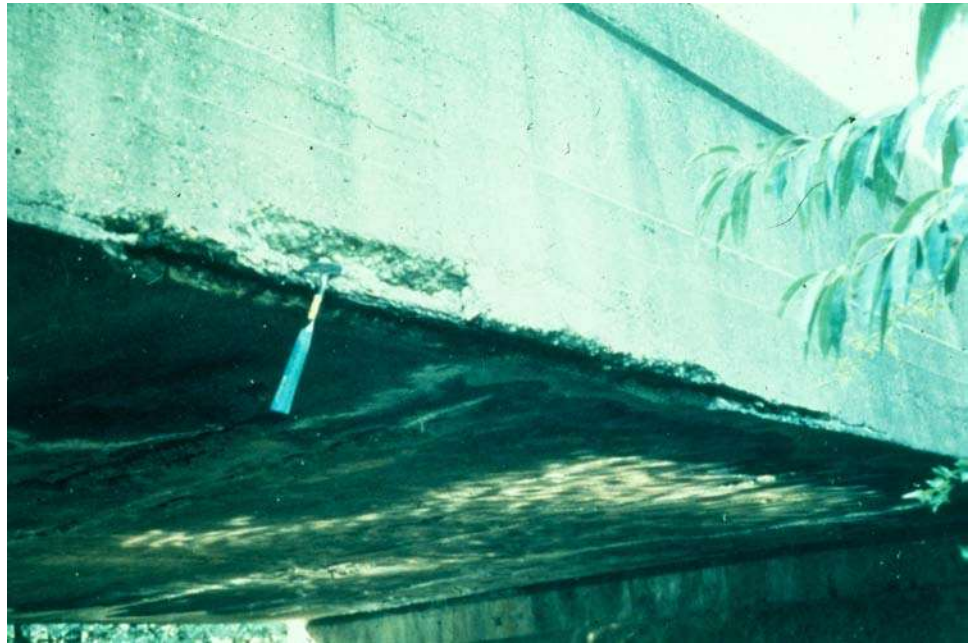
**Figure 9.3.8** Exposed Reinforcement in a Through Two-Girder (under hammer)

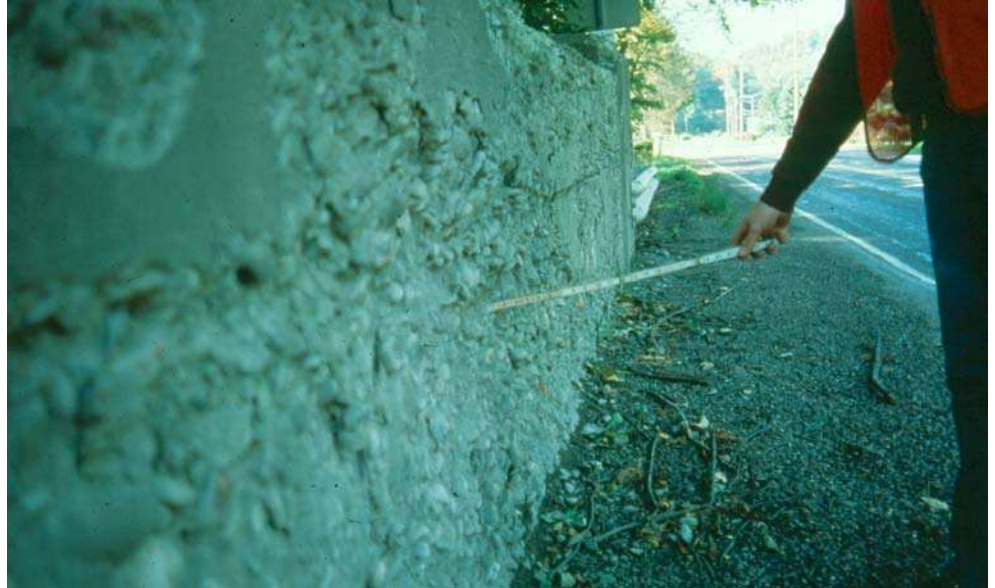
**Figure 9.3.9** Close-up of an Interior Face of a Through Two-Girder with Heavy Scaling due to Deicing Agents

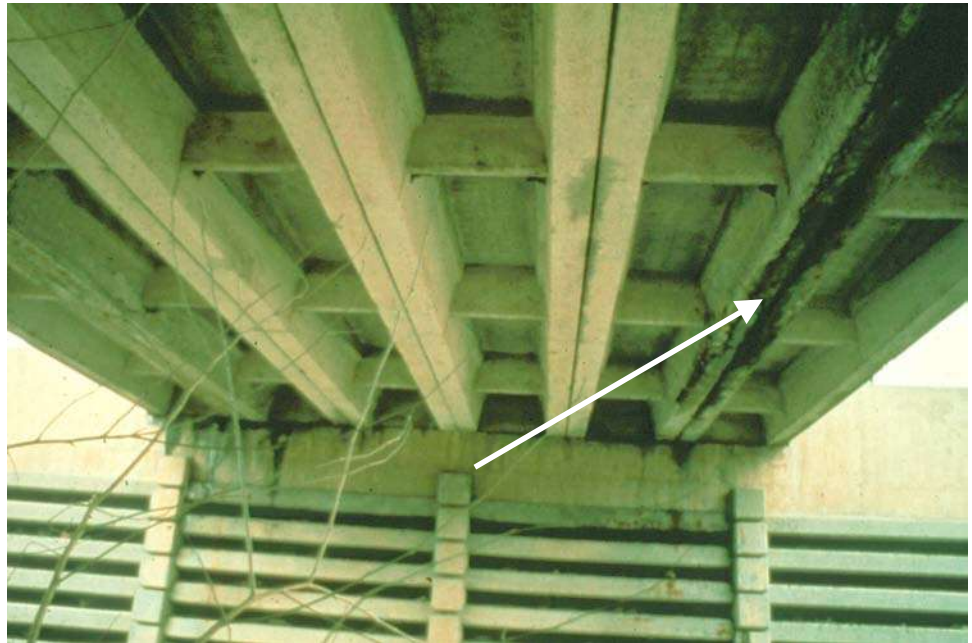
**Figure 9.4.5** Joint Leakage Between Channel Beams

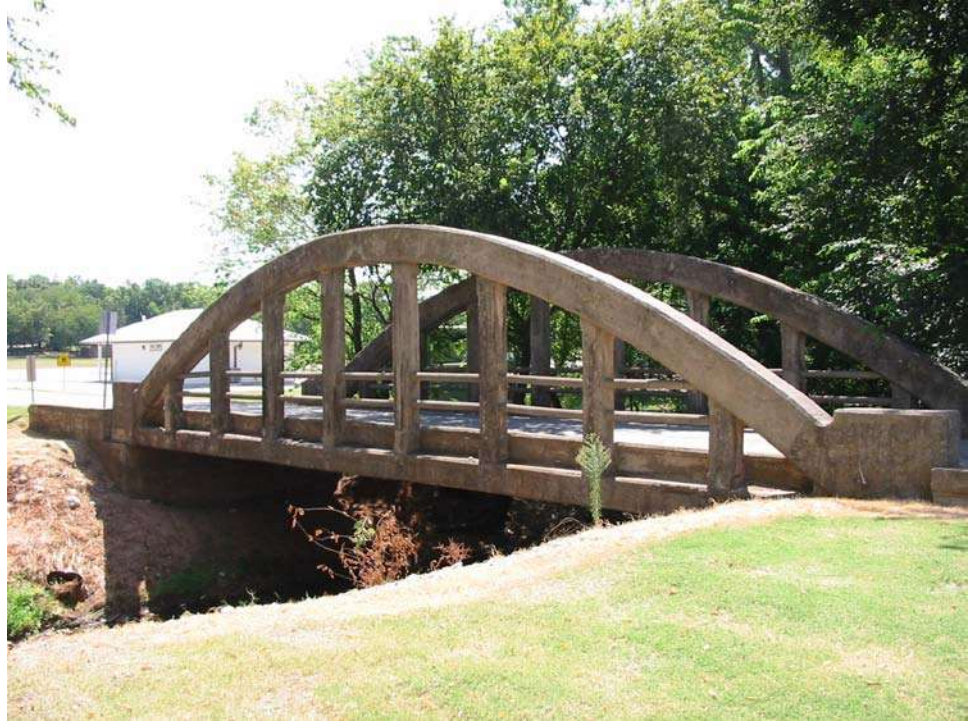
**Figure 9.5.3** Concrete Through Arch Bridge

A concrete through arch is constructed having the crown of the arch above the deck and the arch foundations below the deck. Hangers or cables suspend the deck from the arch. Concrete through arches are very rare (see Figure 9.5.3). These types of arches are sometimes referred to as "Rainbow Arches".

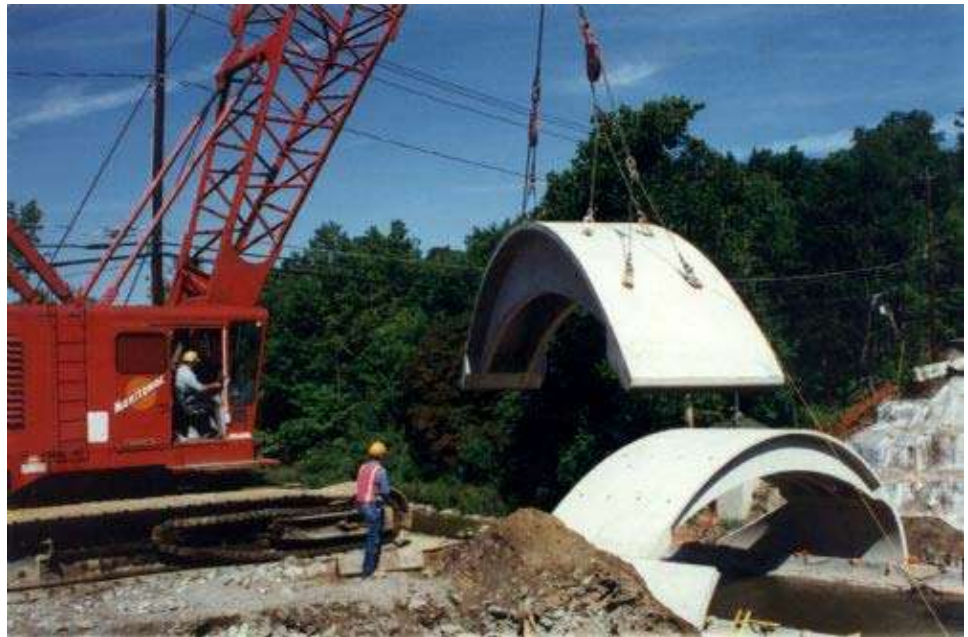
**Figure 9.5.5** Precast Segmental Concrete Arch

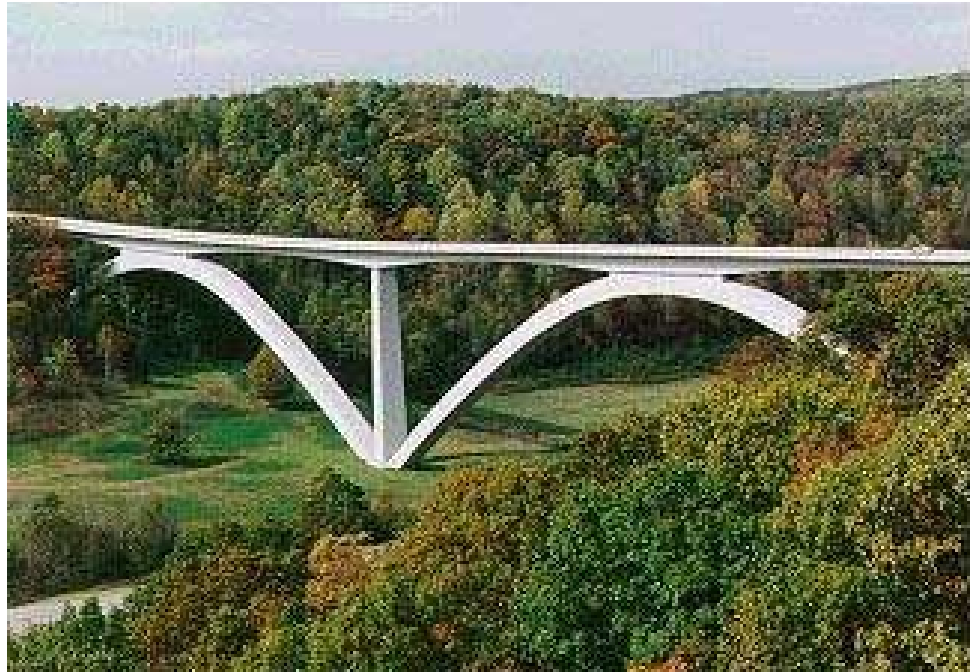
**Figure 9.5.6** Precast Post-tensioned Concrete Arch without Spandrel Columns

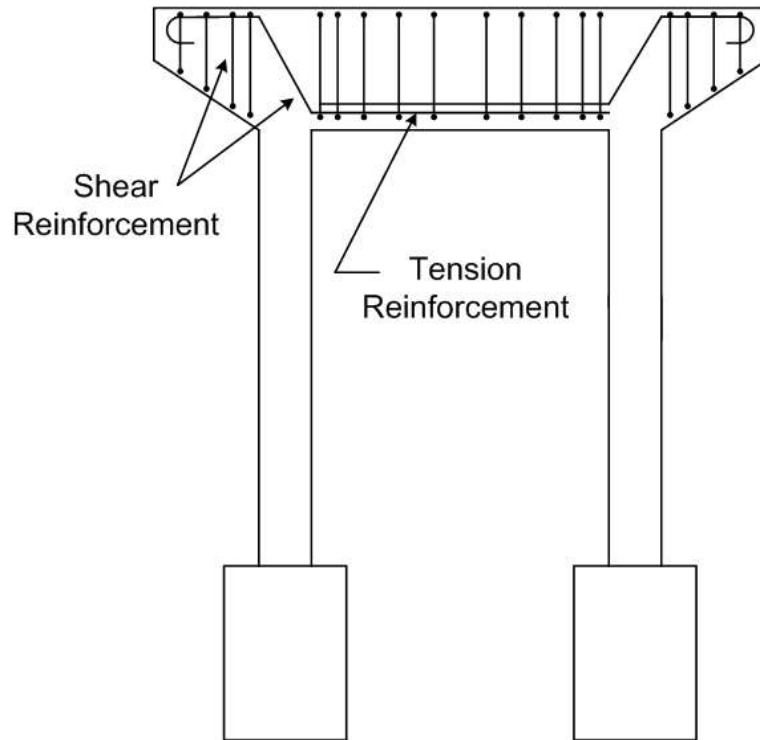
**Figure 9.5.10** Spandrel Bent Cap Reinforcement
