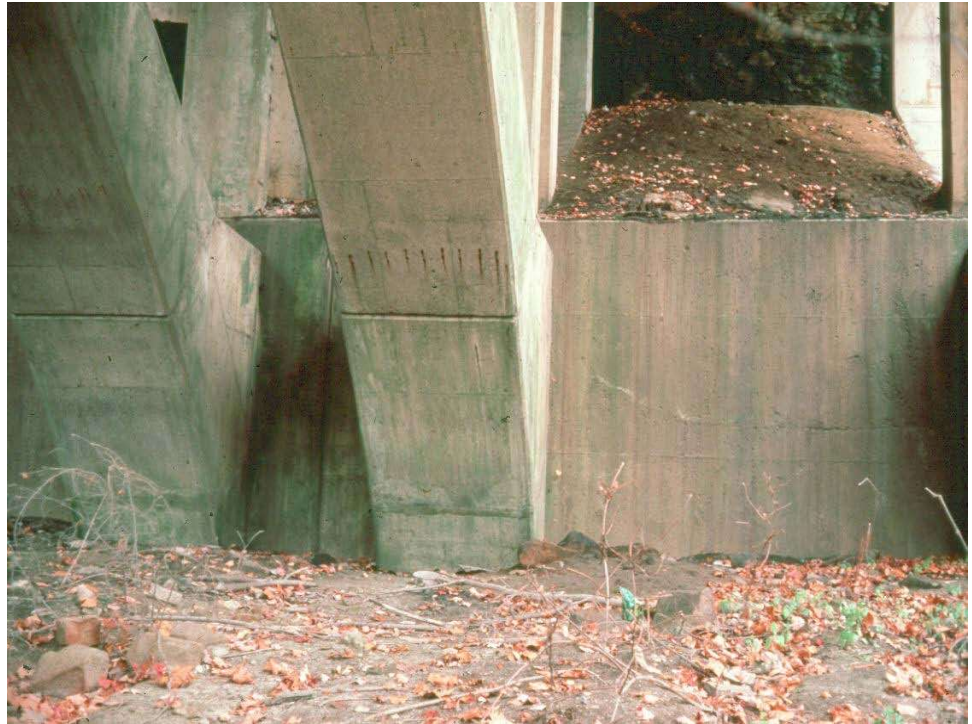
**Figure 9.5.12** Arch/Skewback Interface

Examine the arch ring for unsound concrete. Look for rust stains, cracks, discoloration, crushing, and deterioration of the concrete. Inspect the interface between the spandrel wall and the arch for spalls that could reduce the bearing area. Investigate the arch for transverse cracks, which indicate an overstress condition.

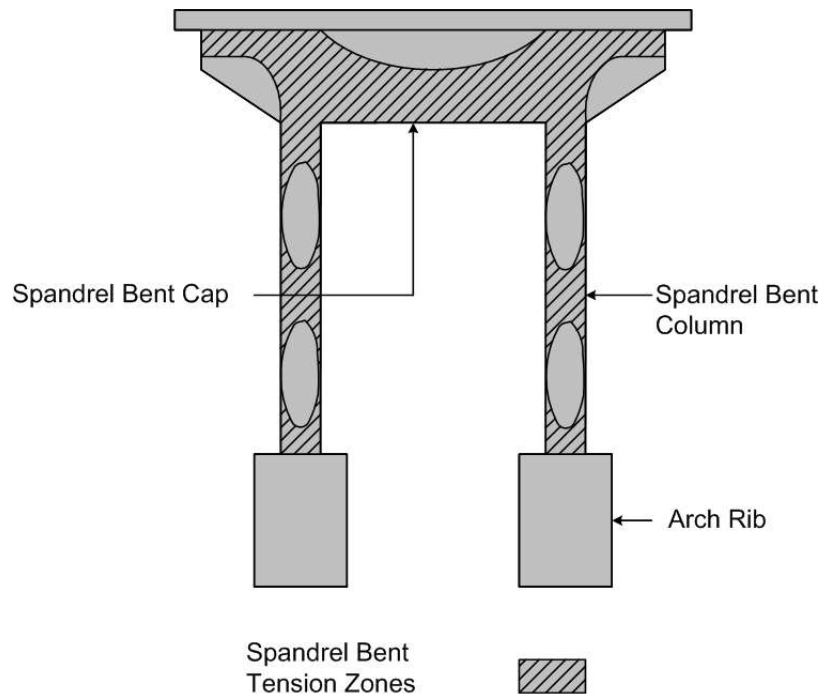
**Figure 9.5.14** Spandrel Bent Tension Zones

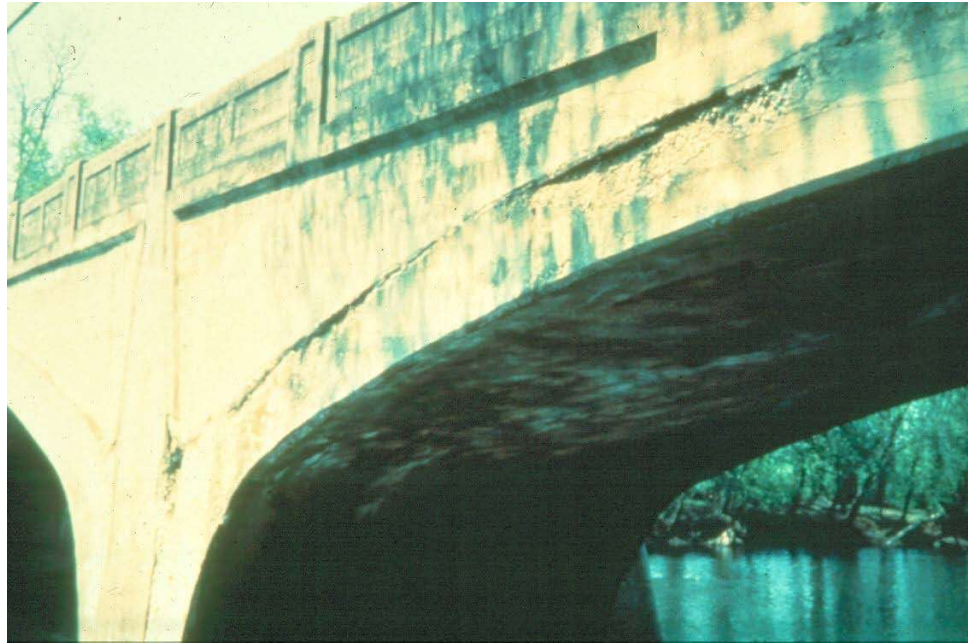
**Figure 9.5.15** Deteriorated Arch/Spandrel Wall Interface

Inspect the spandrel walls for sound concrete. Look for cracks, movement, and general deterioration of the concrete (see Figure 9.5.15).

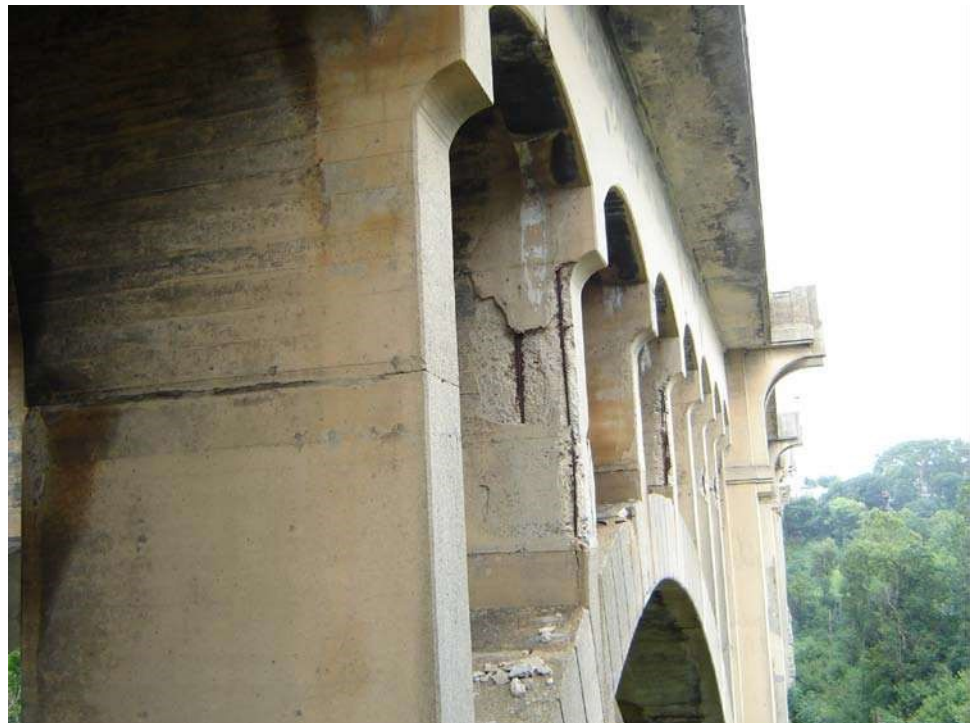
**Figure 9.5.16** Severe Scaling and Spalling on a Spandrel Column

Investigate the compression areas throughout the arches and spandrel columns (not only at the bearing areas). Transverse or lateral cracks indicate excessive surface stresses caused by buckling forces and bending moment (see Figure 9.5.16).

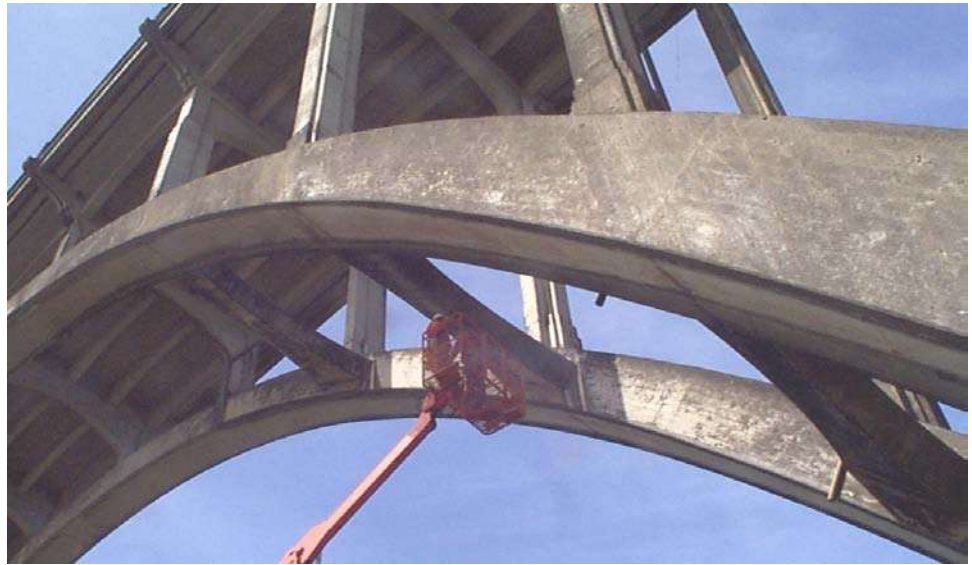
**Figure 9.5.17** Inspection and Documentation of Arch Strut Deficiencies

Inspect diaphragms and struts for flexural and shear cracks, as well as for typical concrete deficiencies (see Figure 9.5.17). Deficiencies in the secondary members may be an indication of differential settlement of the substructure or differential deflection of the concrete arches.

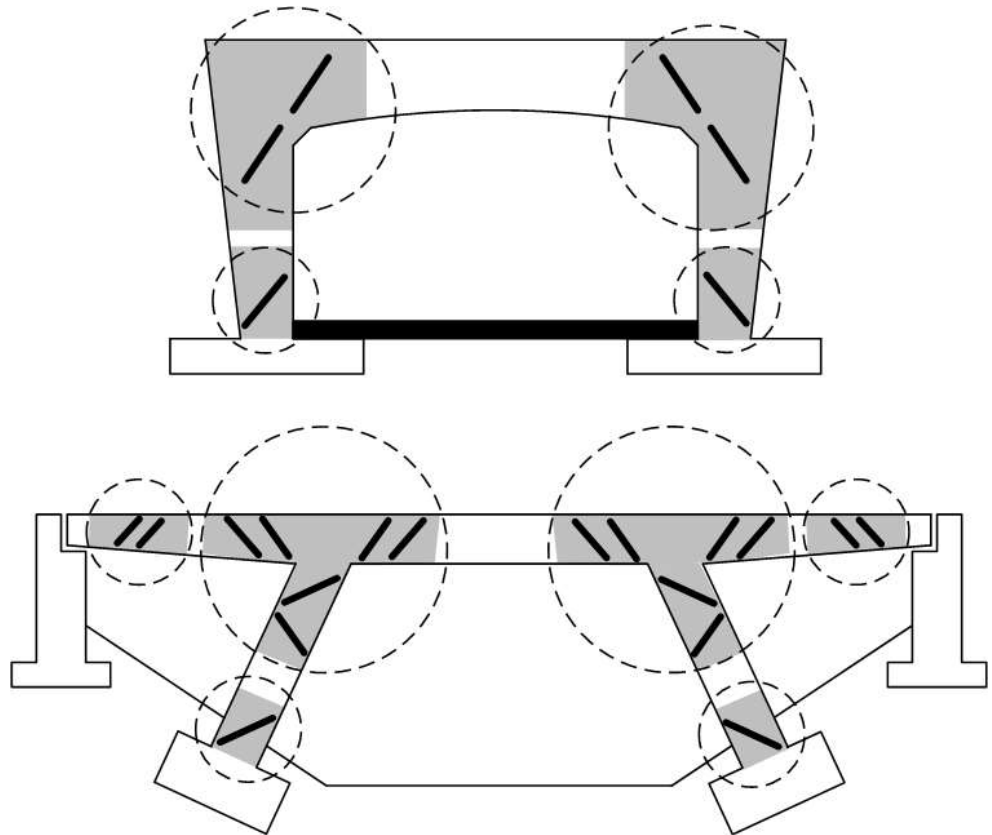
**Figure 9.6.10** Shear Zones in Single Span and Multi-span Frames

Inspect the frame legs for diagonal cracks that initiated at the frame beam/slab or footing (see Figure 9.6.10).

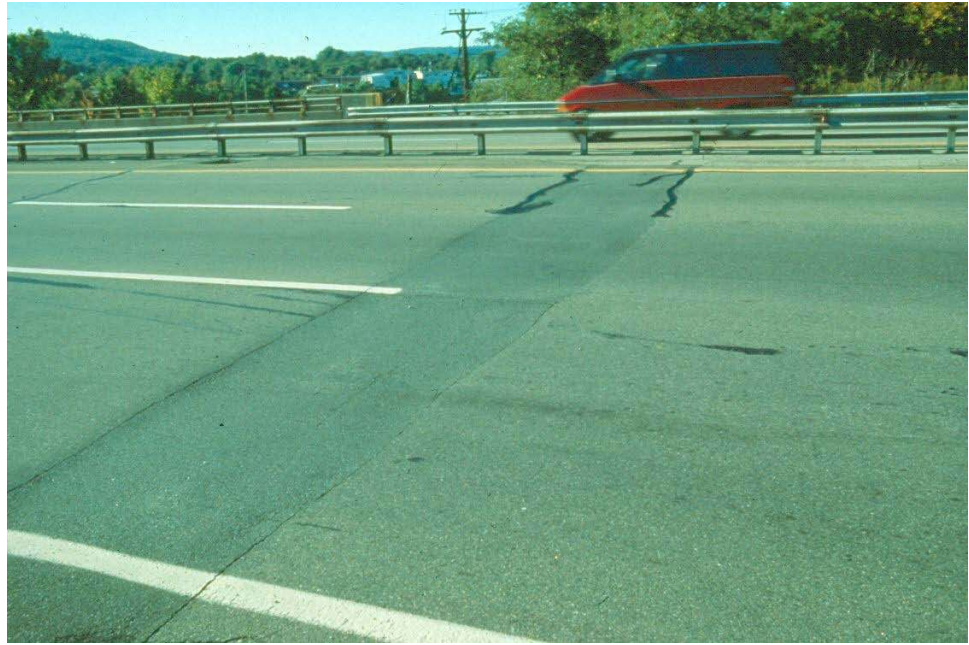
**Figure 9.6.13** Roadway of a Rigid Frame Bridge with Asphalt Wearing Surface

Examine the areas exposed to drainage for deteriorated and contaminated concrete. Check the roadway surface of the slab or frame beams for delamination and spalls (see Figure 9.6.13). Give special attention to the tension zones and water tables.

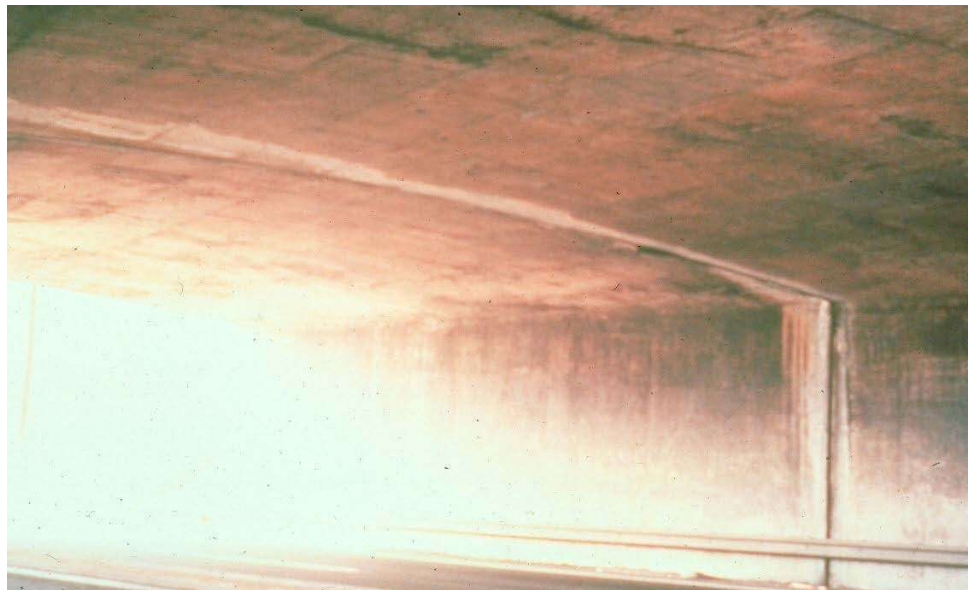
**Figure 9.6.14** Longitudinal Joint Between Slab Frames

Check longitudinal joint areas of adjacent slab or frame beams for leakage and concrete deterioration (see Figure 9.6.14). Check around scuppers and drain holes for deteriorated concrete. Check slab or frame beam ends for deterioration due to leaking deck joints at the abutments. Check to see if weep holes are functioning

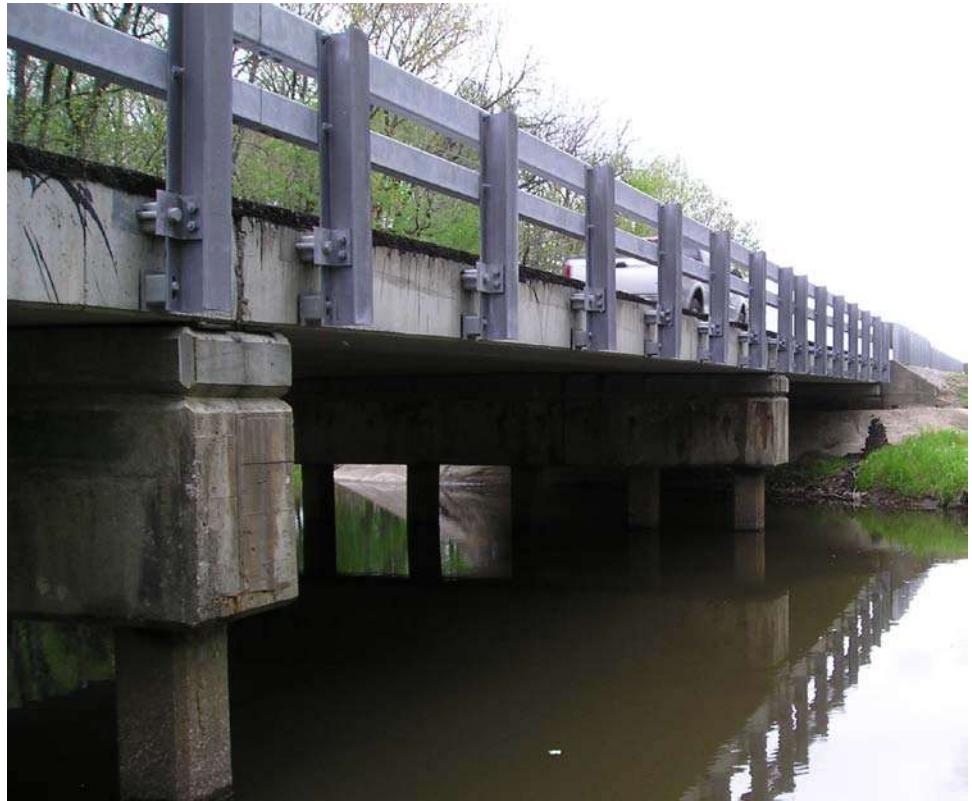
**Figure 9.7.1** Typical Prestressed Slab Beam Bridge

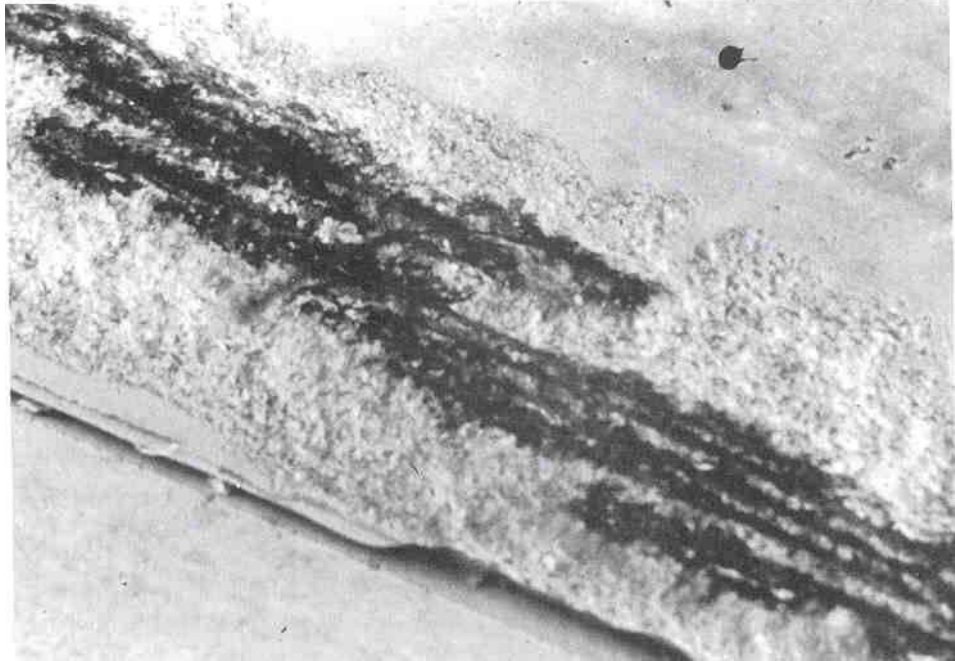
**Figure 9.7.7** Exposed Strands in a Precast Slab Beam

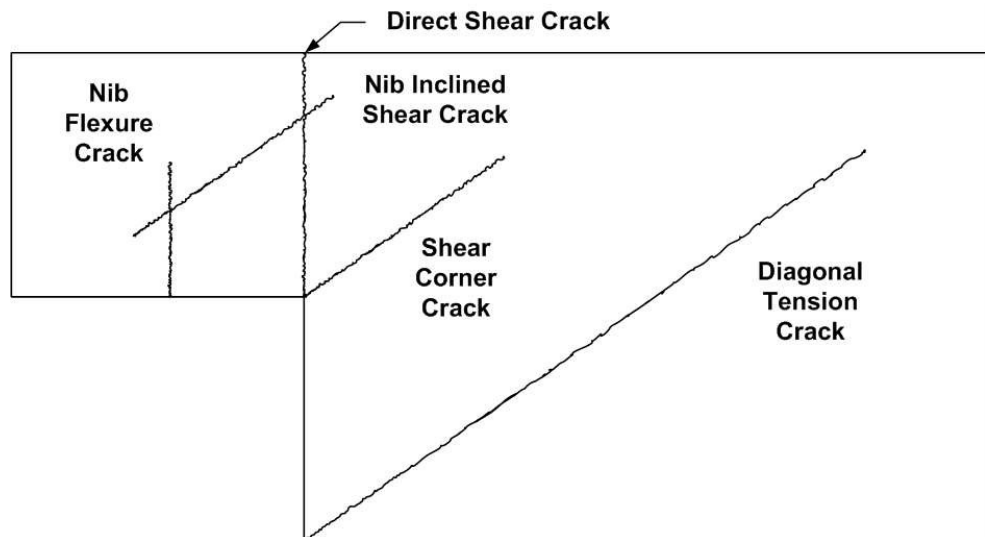
**Figure 9.8.5** Crack Locations for Dapped End Double Tee Beams

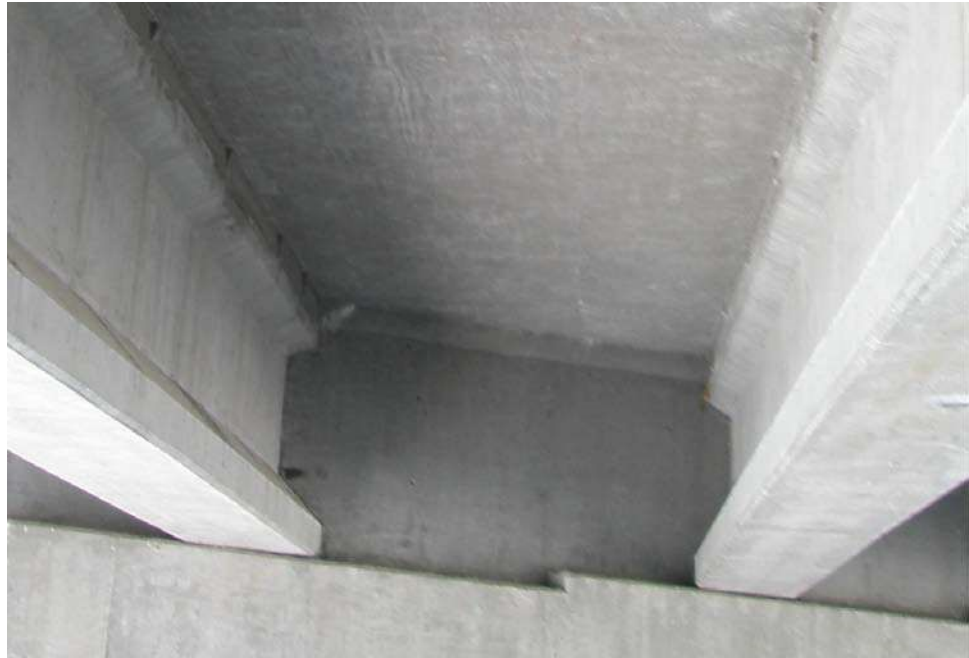
**Figure 9.9.15** Bearing Area of a Typical Prestressed I-beam

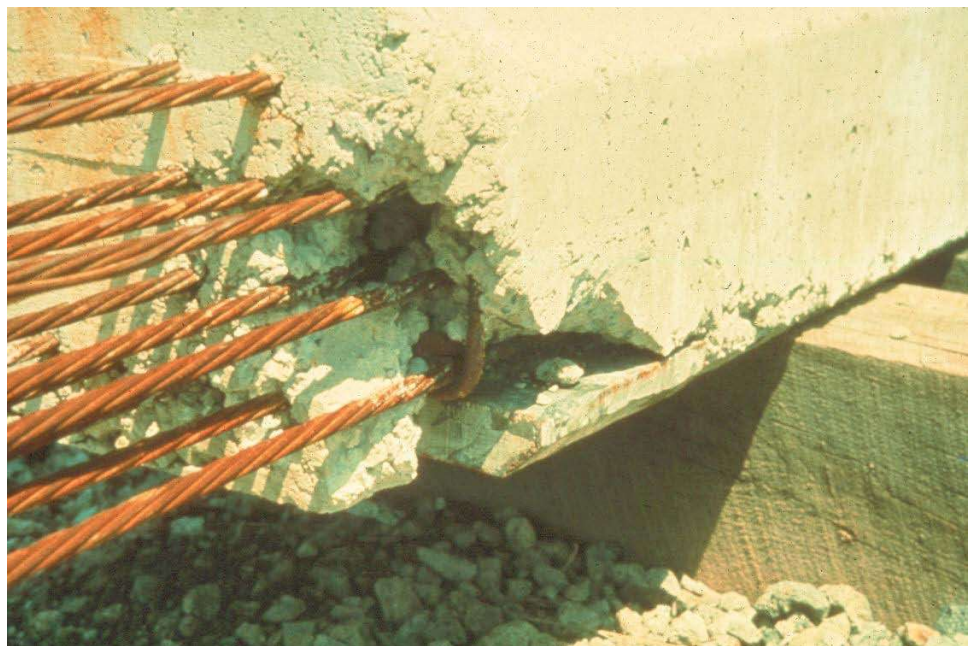
**Figure 9.9.16** Spalling Due to Poor Concrete Placement

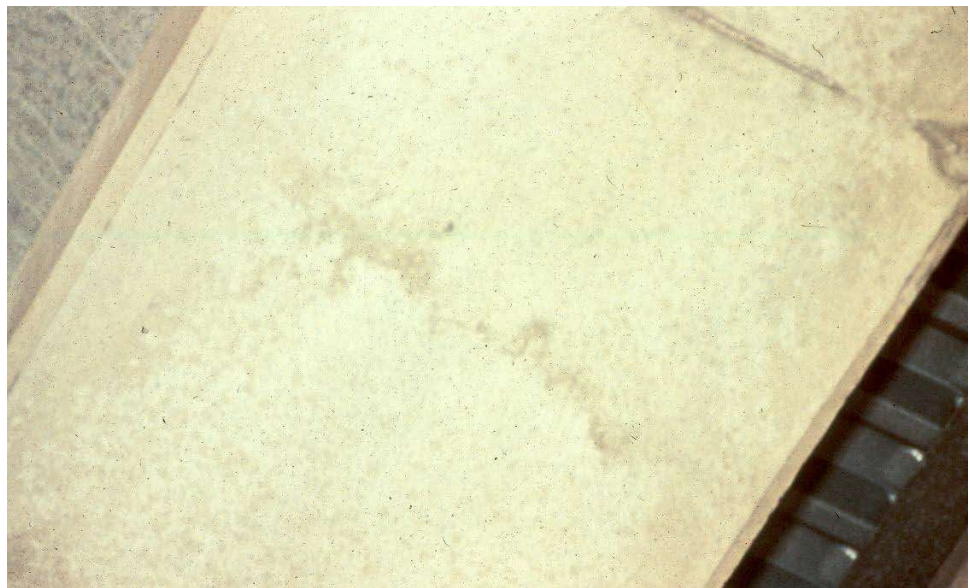
**Figure 9.9.17** Flexure Crack

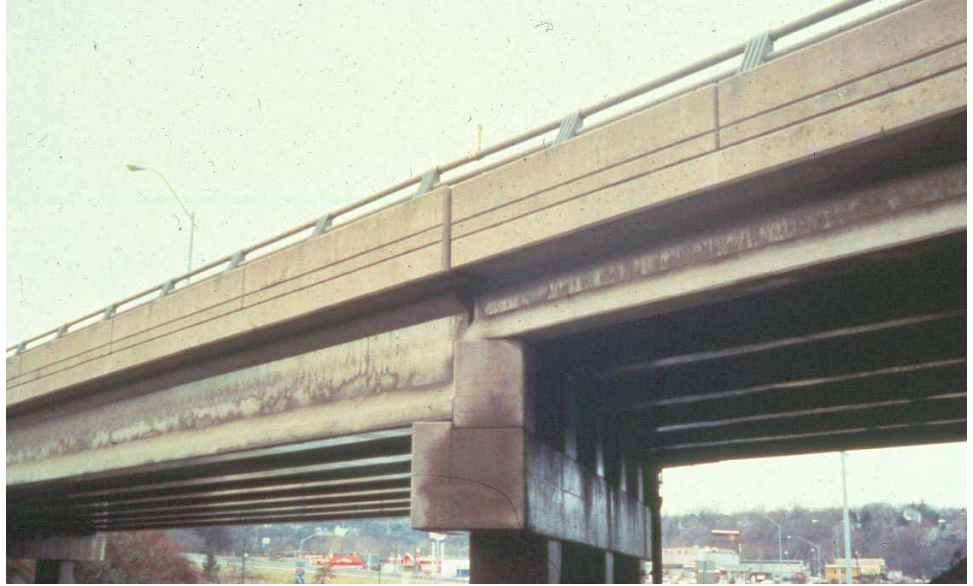
**Figure 9.9.19** Leakage of Water at Joint between Spans

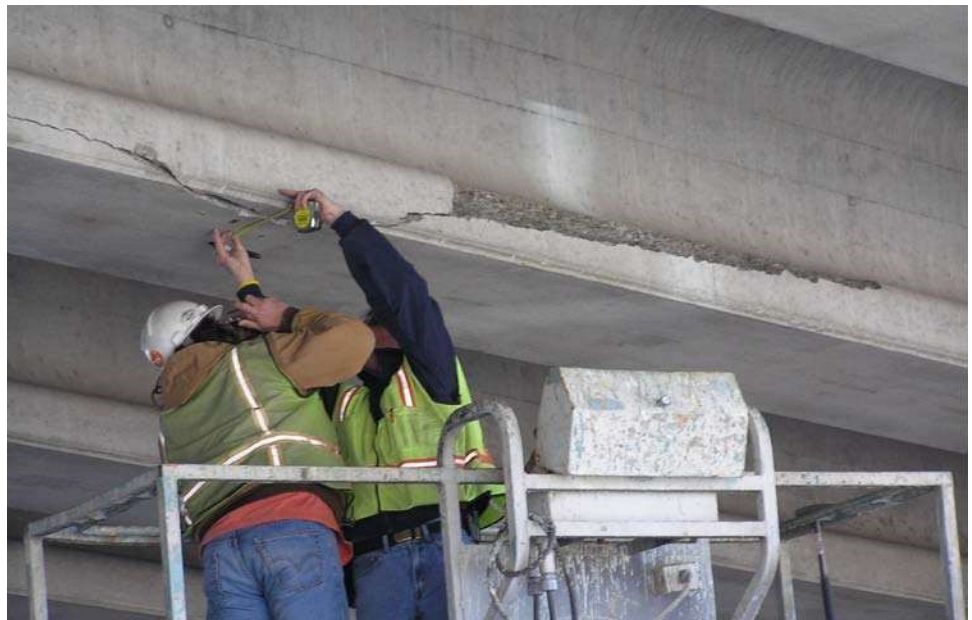
**Figure 9.9.20** Inspectors Evaluating Collision Damage on Prestressed Concrete I-beam

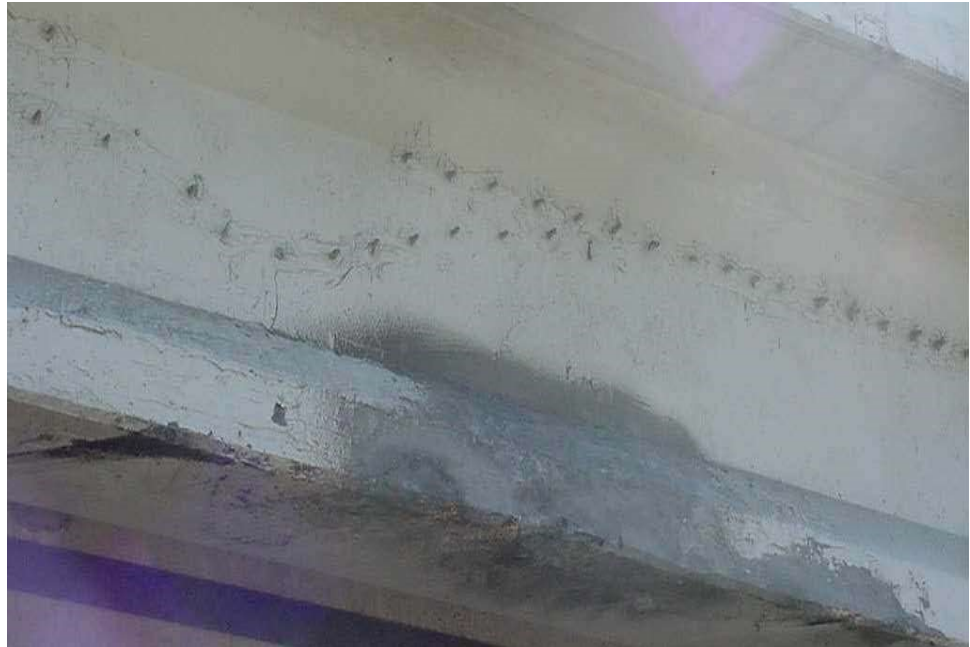
**Figure 9.9.21** Collision Damage Repair on Prestressed Concrete I-Beam. Note Epoxy Injection Ports and Guniting Repair

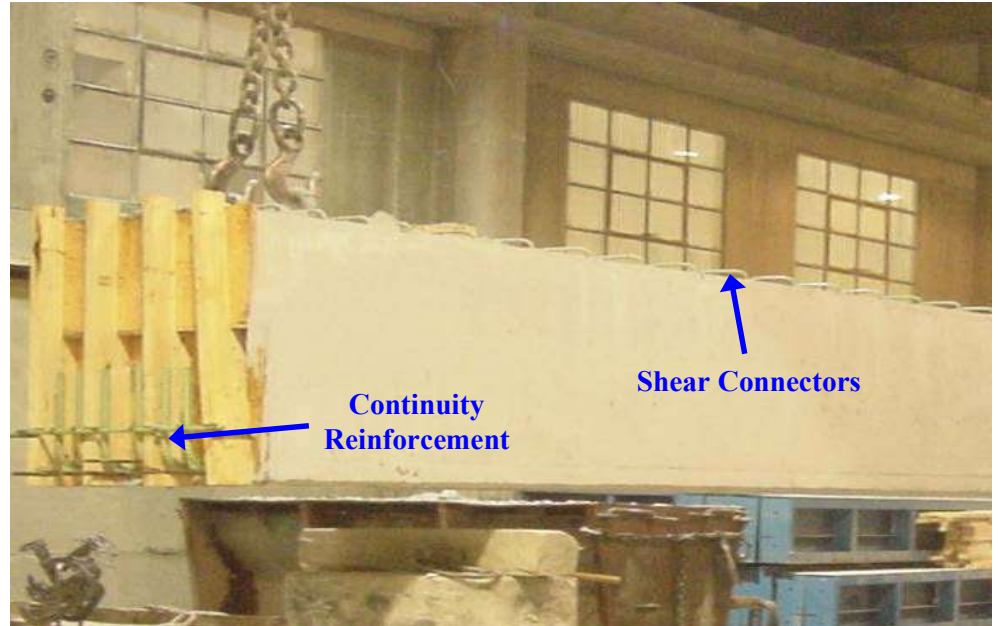
**Figure 9.10.3** Box Beams at Fabrication Plant Showing Stirrups Extended as Shear Connectors and Extended Reinforcement for Continuity

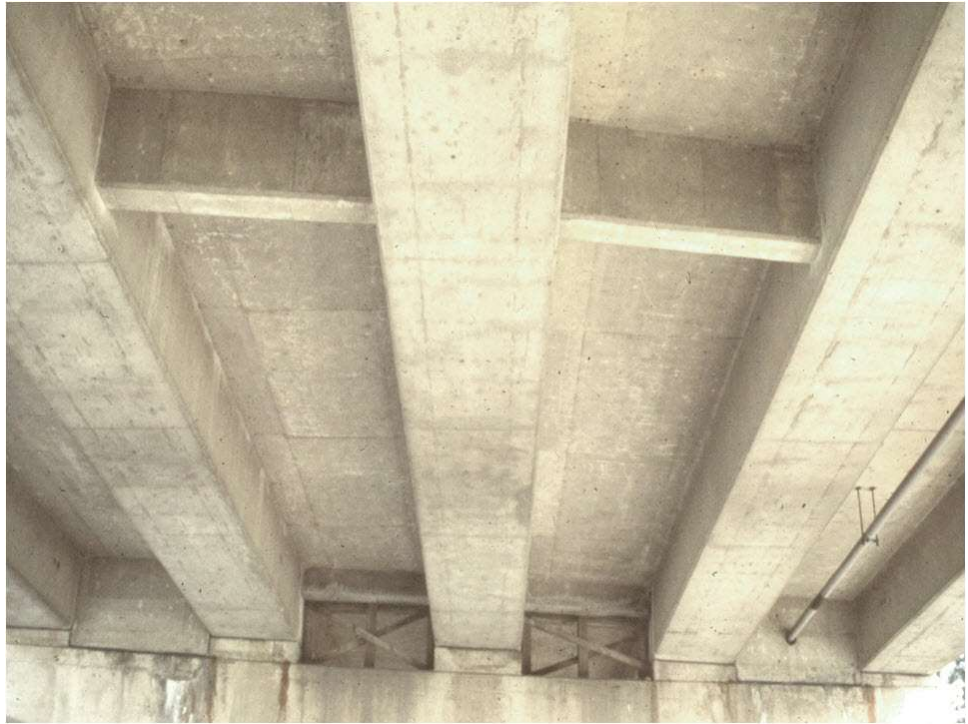
**Figure 9.10.8** End and Intermediate Diaphragms on a Spread Box Beam Bridge

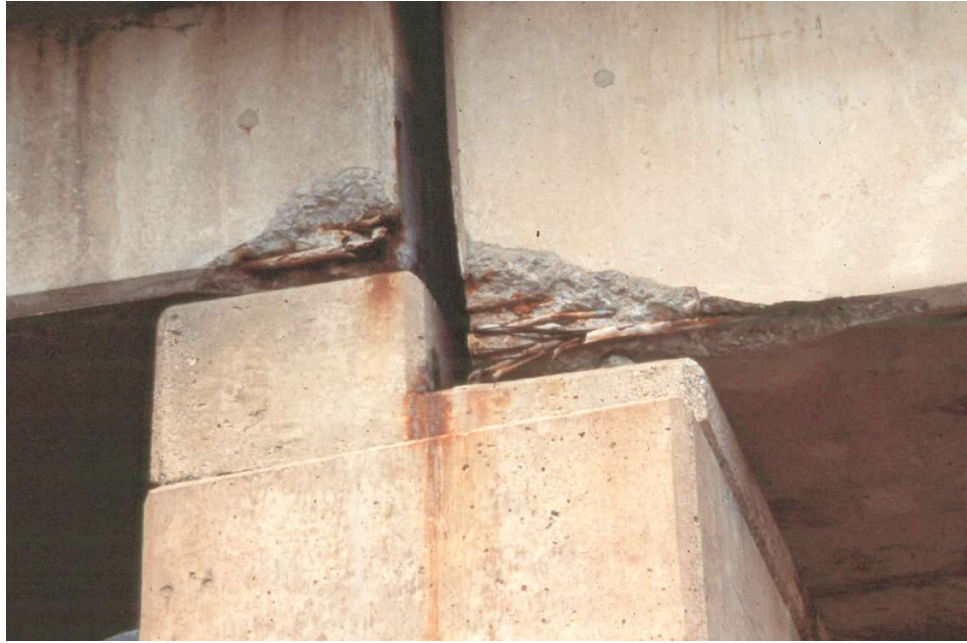
**Figure 9.10.11** Spalled Beam Ends with Exposed Prestressing Reinforcement

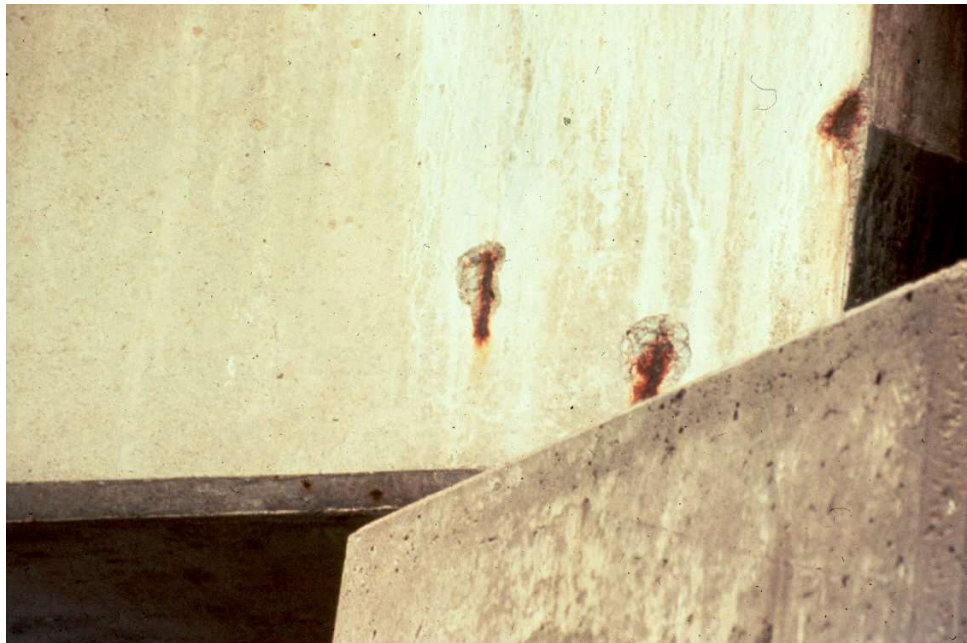
**Figure 9.10.12** Exposed Shear Reinforcement at End of Box Beam

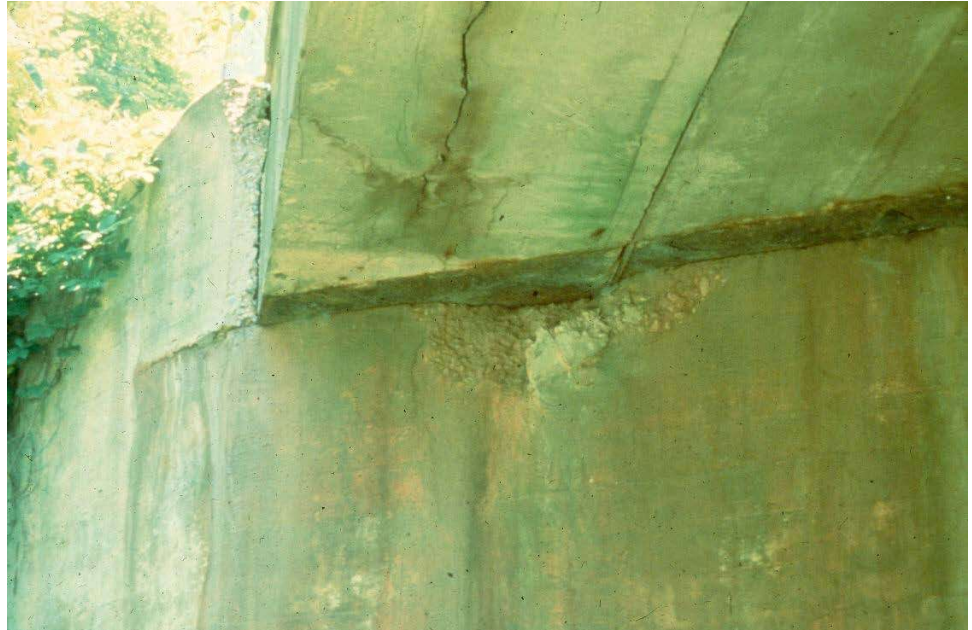
**Figure 9.10.13** Longitudinal Cracks in Bottom Flange of Beam

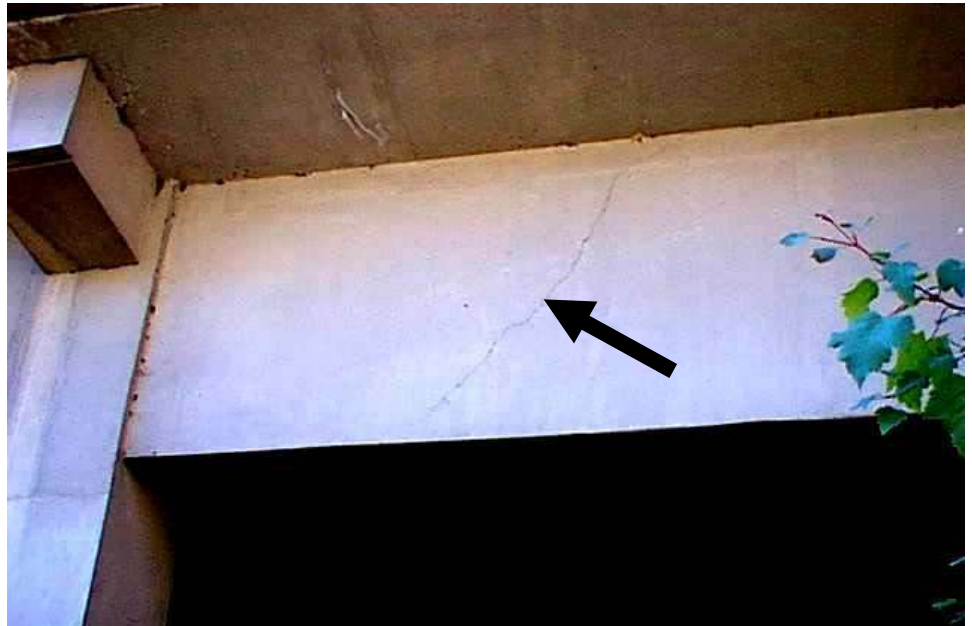
**Figure 9.10.14** Diagonal Shear Crack in Web of Beam

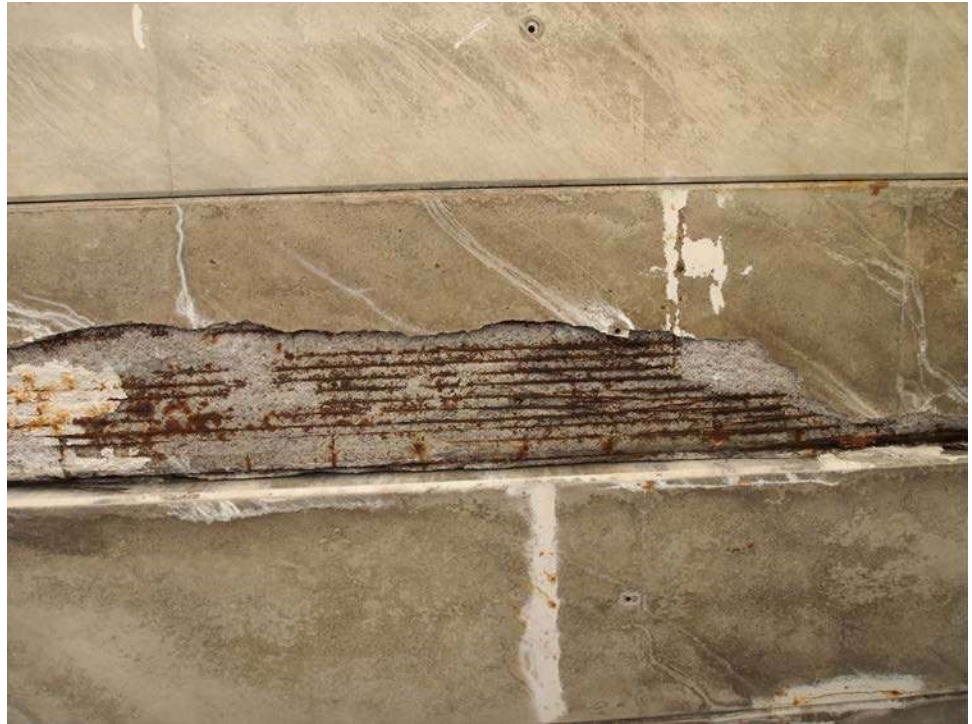
**Figure 9.10.15** Spall and Exposed/Corroded Reinforcement

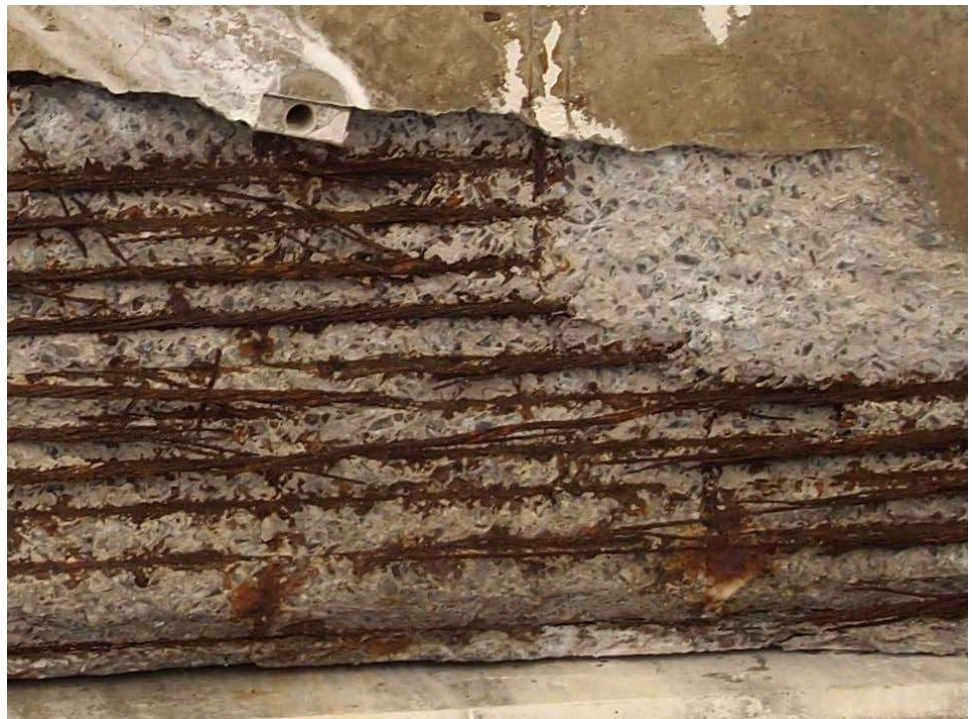
**Figure 9.10.16** Close-up of Failed Strands due to Corrosion

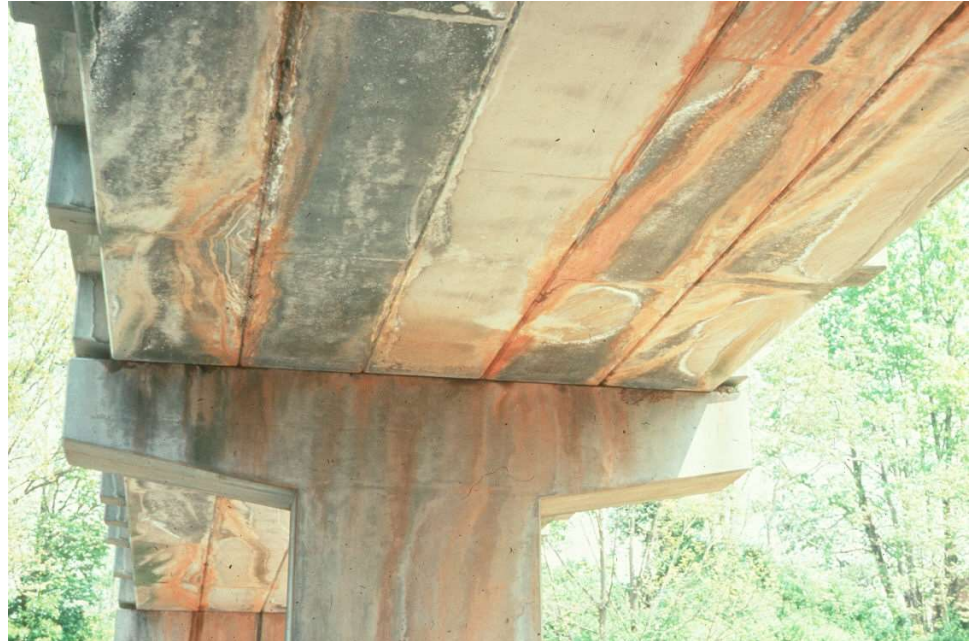
**Figure 9.10.17** Joint Leakage and Rust Stain

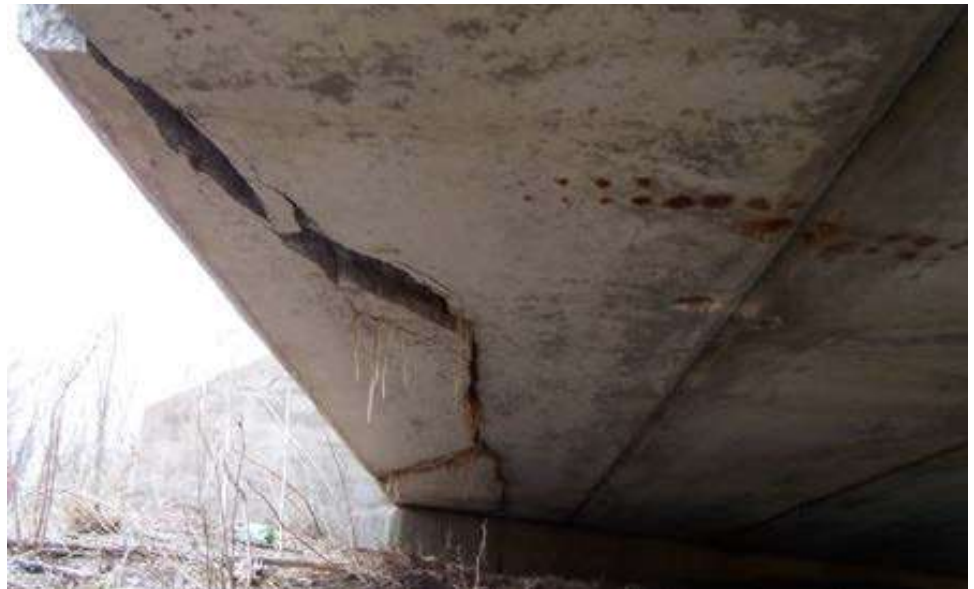
**Figure 9.10.18** Close-up of Box Beam Collision Damage

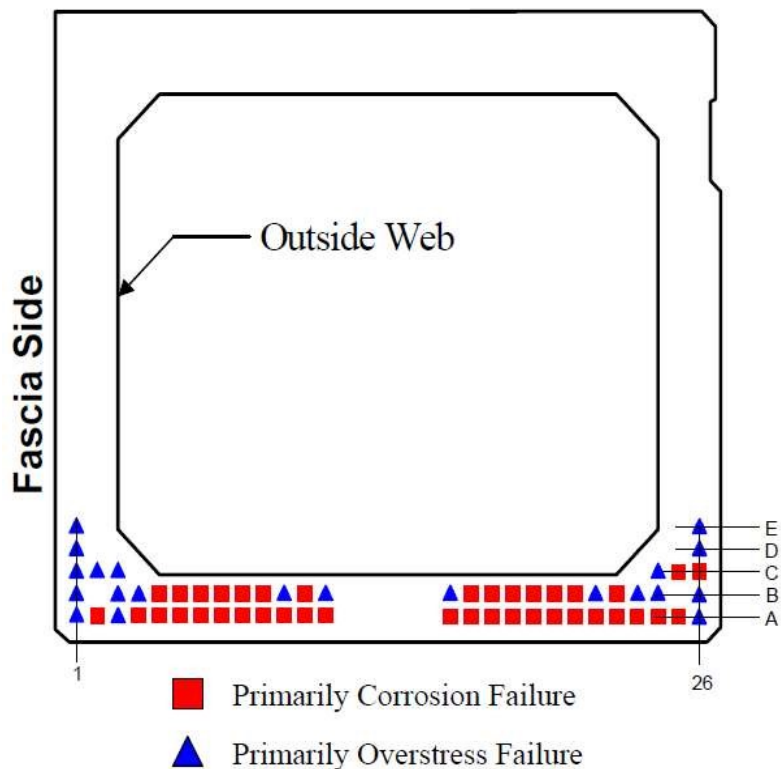
**Figure 9.10.23** Post-Collapse Prestressing Strand Wire Fracture Laboratory Assessment

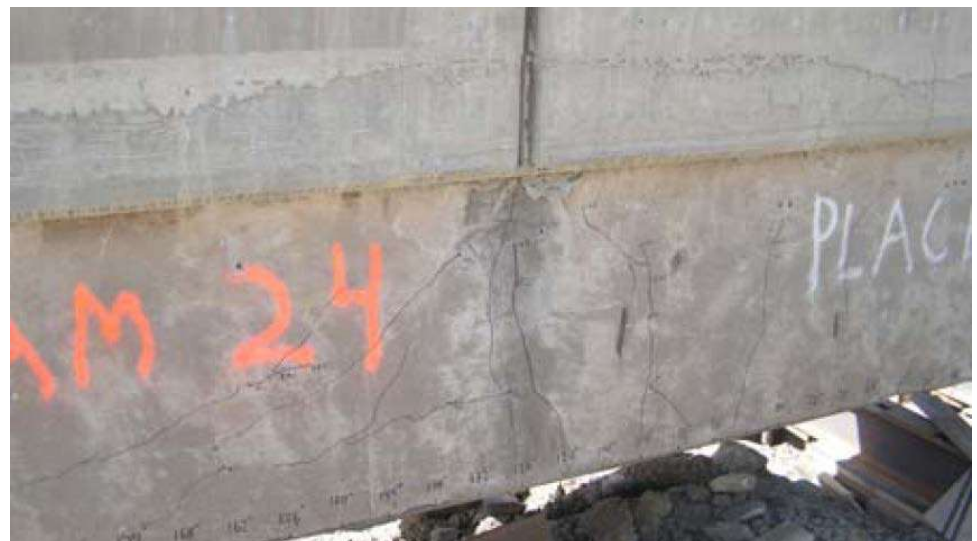
**Figure 9.10.28** Cracking Near Barrier Joints

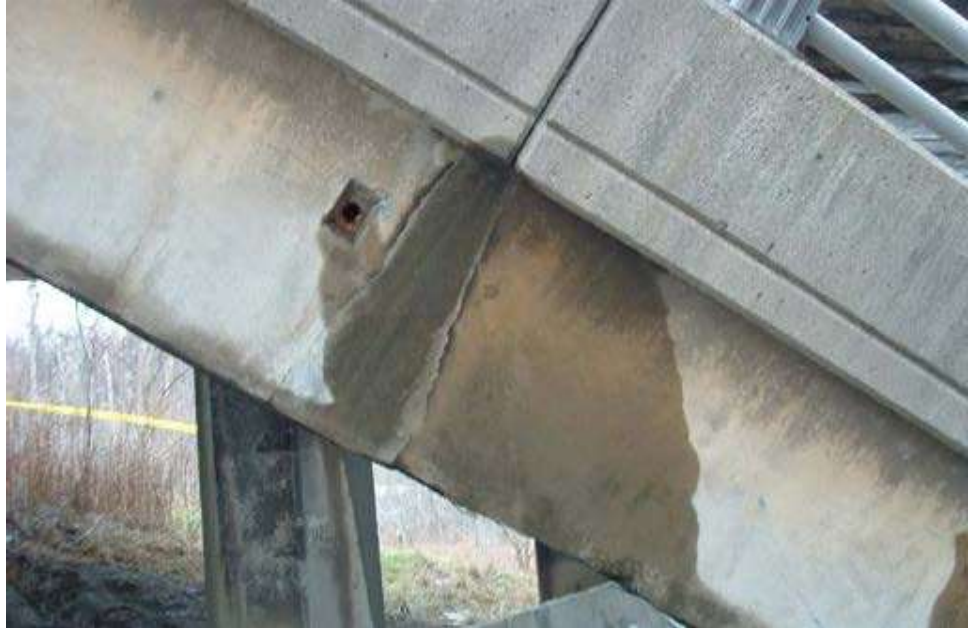
**Figure 9.10. 29** Water Leakage Through Parapet Deflection Joints

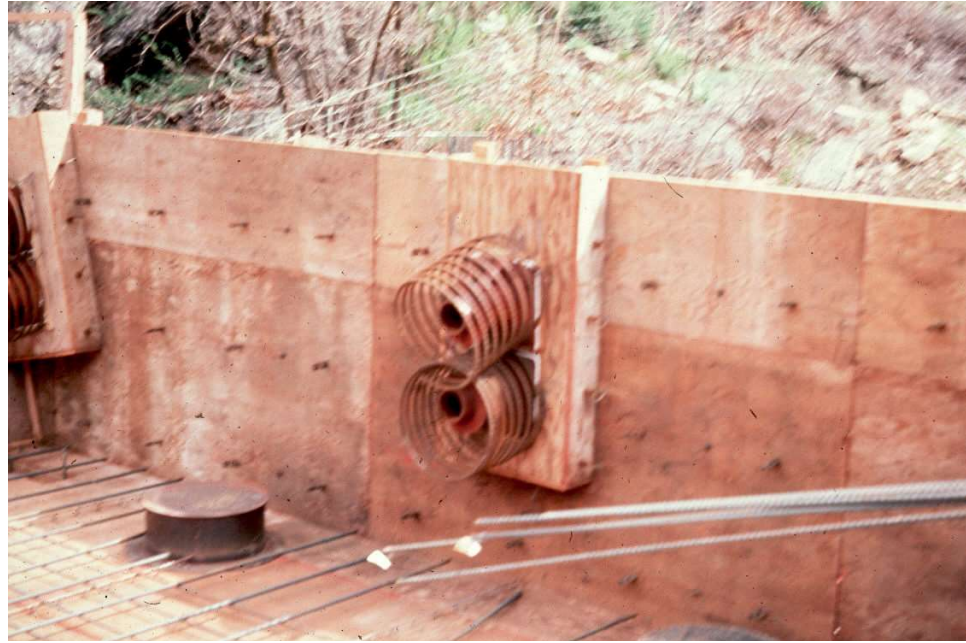
**Figure 9.11.11** Post-tensioning Spiral Anchorage Reinforcement Prior to Concrete Placement
